Nomad

SERVICE BULLETIN

FLIGHT CONTROLS-FITMENT OF MASS BALANCE TO RUDDER TAB

NMD-27-3
Page 6 of 6

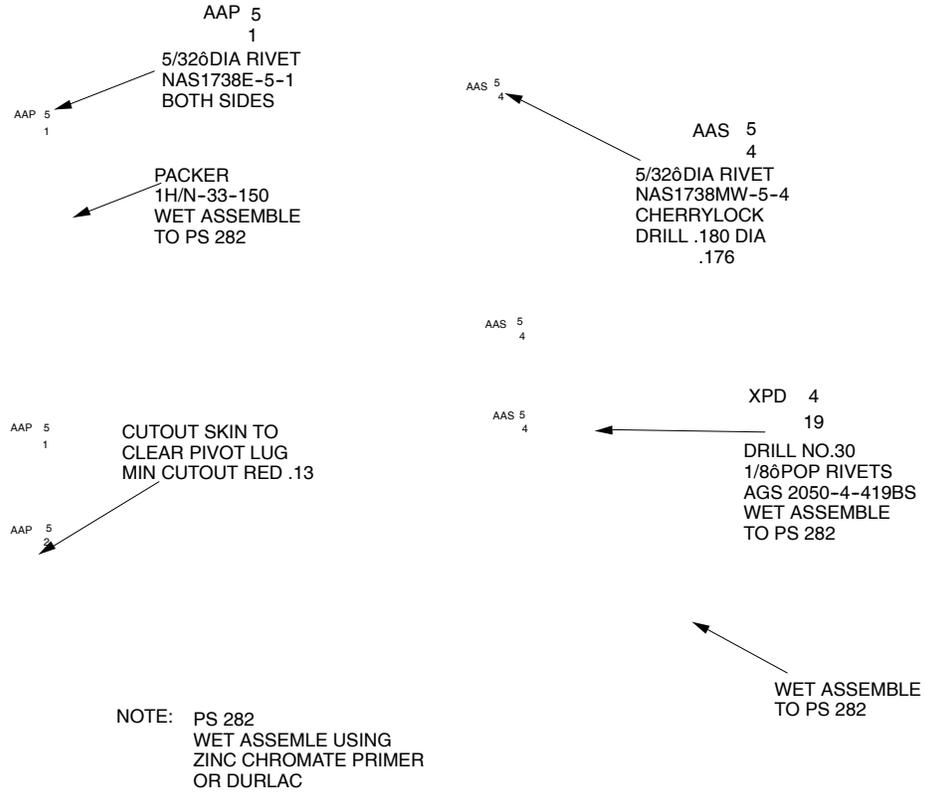
Figure 1 Fixing Mas Balance To Rudder Trim Tab

Tests carried out at GAF have indicated that wear and backlash which may develop in the Rudder Tab operating system during service, may erode to an unacceptable degree the flutter speed reserves which were designed into the system. The fitment of a mass balance to the Tab lifts flutter speed well above the original reserve, and fully compensates for backlash and wear developing during service.

Remove and replace the pop rivets in the tab rib at WL 110 and replace with cherry rivet NAS1738E5-1 (8 places) and NAS1738ES 2 (2 places). Refer figure 1. Relieve the hinge, and skin at tab to obtain clearance for the pivot lug 2/N-33-177 per figure 1.

Locate the packer 1H/N-33-150 and the mass balance plate 1/N-33-178 on the bottom rib ensuring the pivot hole will be in line with the hinge centreline. Using the predrilled mass balance plate as a template, drill (.176/.180) the seven locations. The two rivet locations in the welded flange are to be filled with 1/8 pop rivets. Attach packer and mass balance by applying sealing compound PR1222 or equivalent and cherry lock rivet NAS1738MW5-4. Reidentify the trim tab as 3/N-33-150.
