Nomad

ALERT SERVICE BULLETIN

WINGS — ELECTRICAL — AFT WING BREAK CONNECTOR — INCORPORATION OF MOD N875 (N22) & N876 (N24)

ANMD-57-13

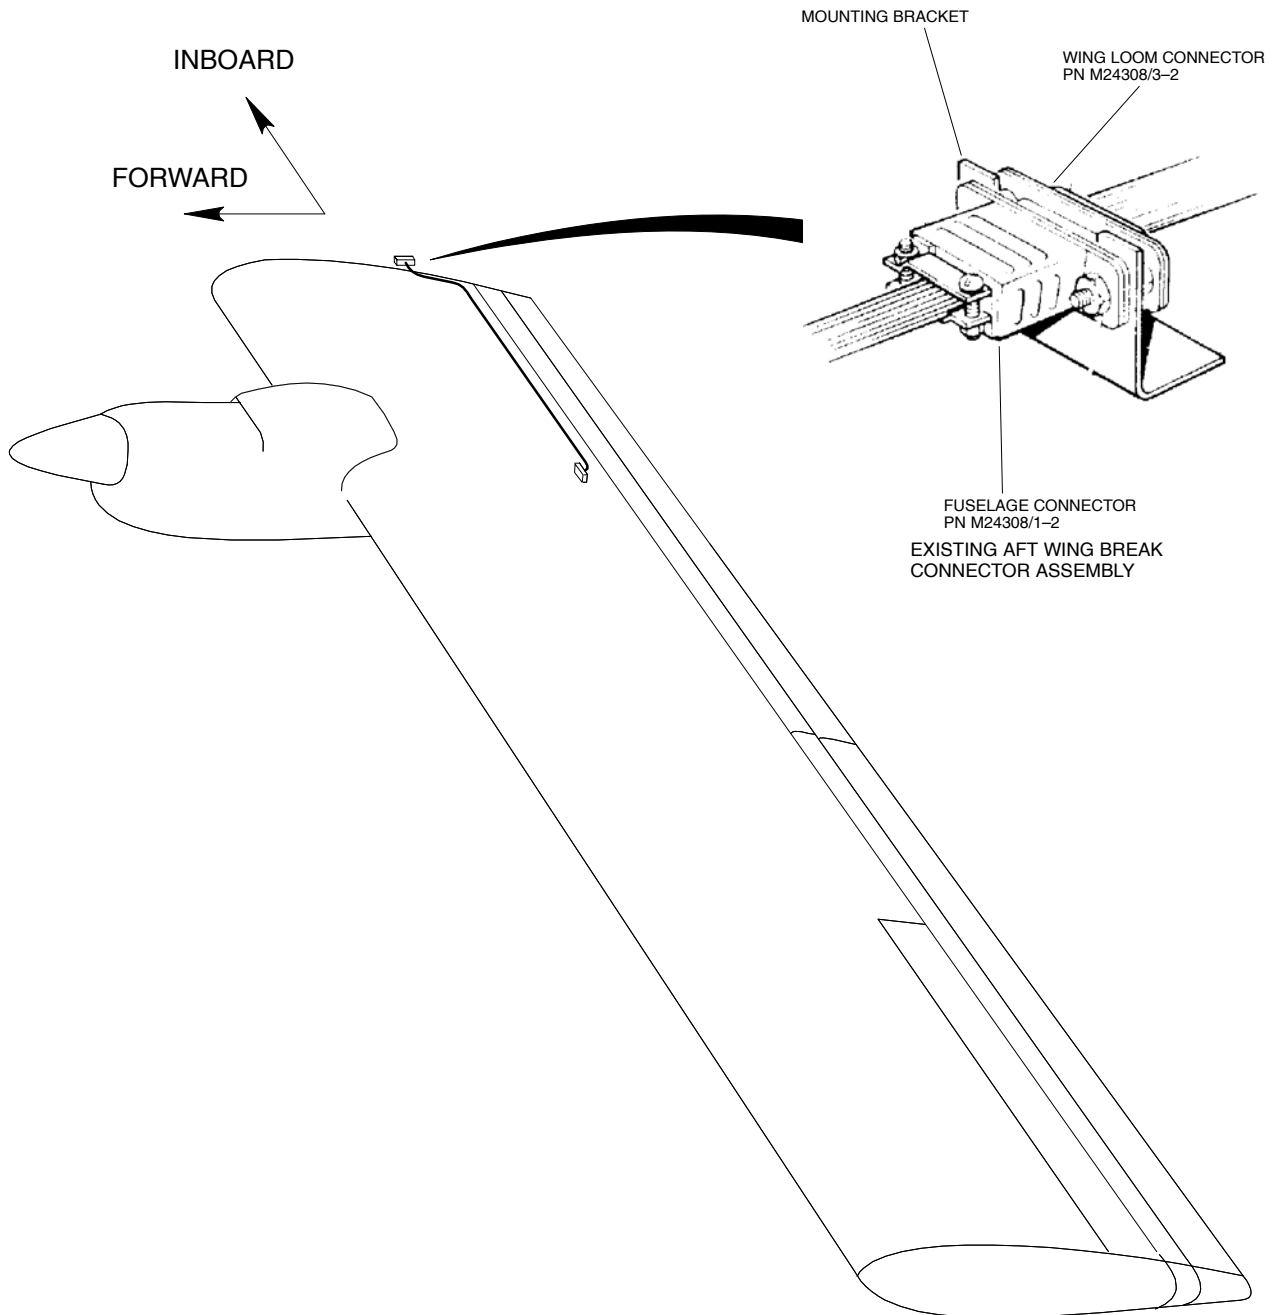
Figure 1 Aft Wing Break Connector – Inspection

Reports have been received of uncommanded flap extensions and incorrect stall warning indications. Contamination in the aft wing break connectors may cause such occurrences.

The aft wing break connectors are to be disassembled (including strain relief) and inspected for corrosion, arcing damage, looseness of contacts and deposits between contacts at the mating faces of the connectors and at the back of the connectors in the strain relief areas.

- (3) Disconnect the aft wing break connector (Ref Fig 1) and remove the fuselage connector from the mounting bracket.
- (4) Remove the strain relief back shells from each connector to enable inspection of both sides of the contact inserts.

- (5) If the connectors are contaminated, thoroughly clean both sides of the connector using a suitable cleaning solvent.
- (6) Inspect the connectors for arcing damage, deposits between contacts and looseness of contacts. If the connectors are found to be unserviceable, omit the following steps (7), (8), (9) and (10) and proceed to Part B.
