FUEL SYSTEM – REWORK OF CHECK VALVES TO PREVENT DAMAGE TO BOOST PUMP ELECTRICAL LEADS

Nomad N22 and N22B aircraft

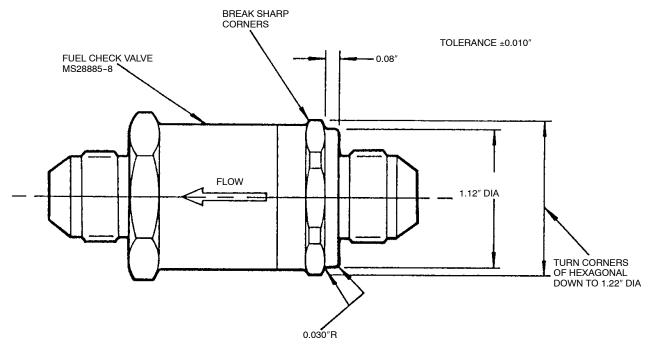
Figure 1 Fuel Check Valve MS28885-8

During assembly of check valve PN MS 28885-8 and Boost Pump PN1C6-14, the pump electrical leads can be damaged and cut by the sharp corners of the hexagonal end of the check valve body.

A. At both inboard fuel sumps remove, fuel check valves PN MS28885-8 as outlined in MM Chap 28-20-00 and rework inlet end of each valve by machining as shown in sketch below.

After rework treat machined surfaces with Alodine.

TREAT MACHINED AREAS WITH ALODINE
