GOVERNMENT AIRCRAFT FACTORIES

SUBJECT: NOMAD SERVICE BULLETIN NMD-39-1 - REVISION 1

SUBJECT: AIRSPEED INDICATOR MODIFICATION TO DIAL MARKINGS

S/B NMD-39-1
Revision 1
Page 1 of 7

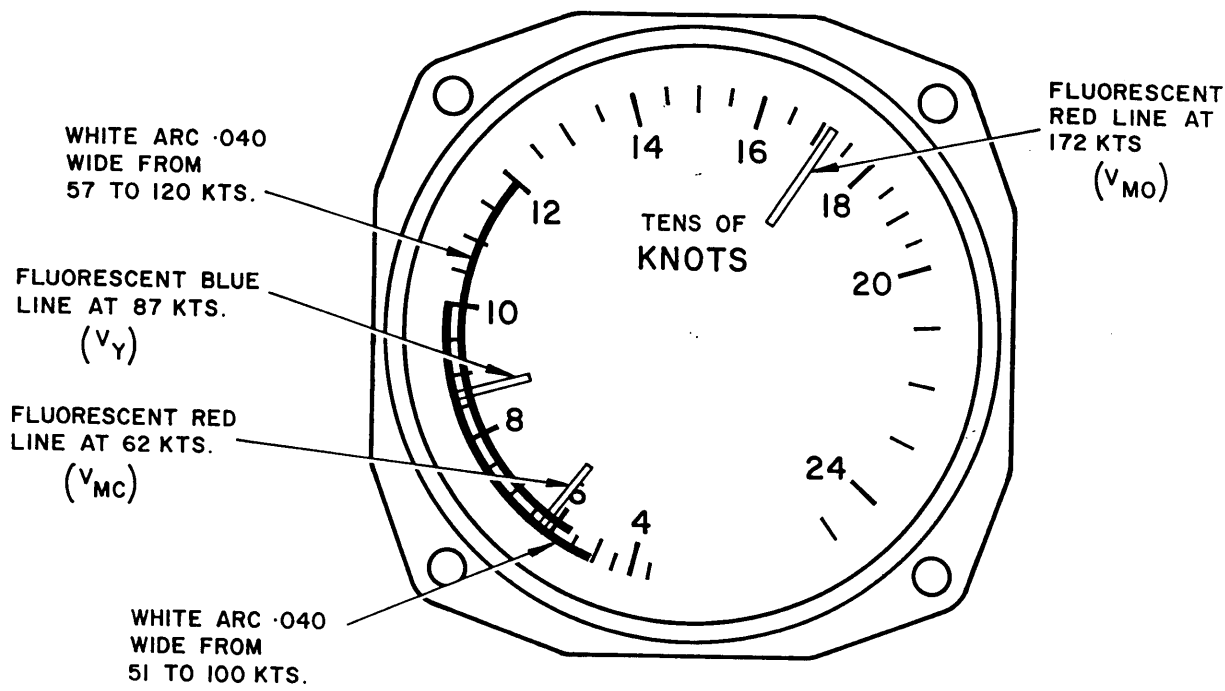
FIG. 1

The dial markings of the airspeed indicator are to have coloured arcs referring to V_{NE} and V_{NO} deleted and replaced by one single red radial referring to V_{MO} at 172kts.

NOTE: The normal operating limitation is not affected as $V_{MO} = V_{NO} = 172$ kts.

ASI FOR N22 PART N° 1/N-80-442 OR EA-5173-(5)-GAF

Replace with the new, overhauled, repaired or reworked unit which has dial markings conforming to Figure 1. Replacement unit is identified by P/No. 1/N-80-442 or EA-5173-(5)-GAF.

NOTE: 1 ASI with dials reworked to Figure 1 by G.A.F. will be P/No. 1/N-80-442. ASI supplied by Edo-Aire ex factory will have marked P/No. EA-5173-(5)-GAF.

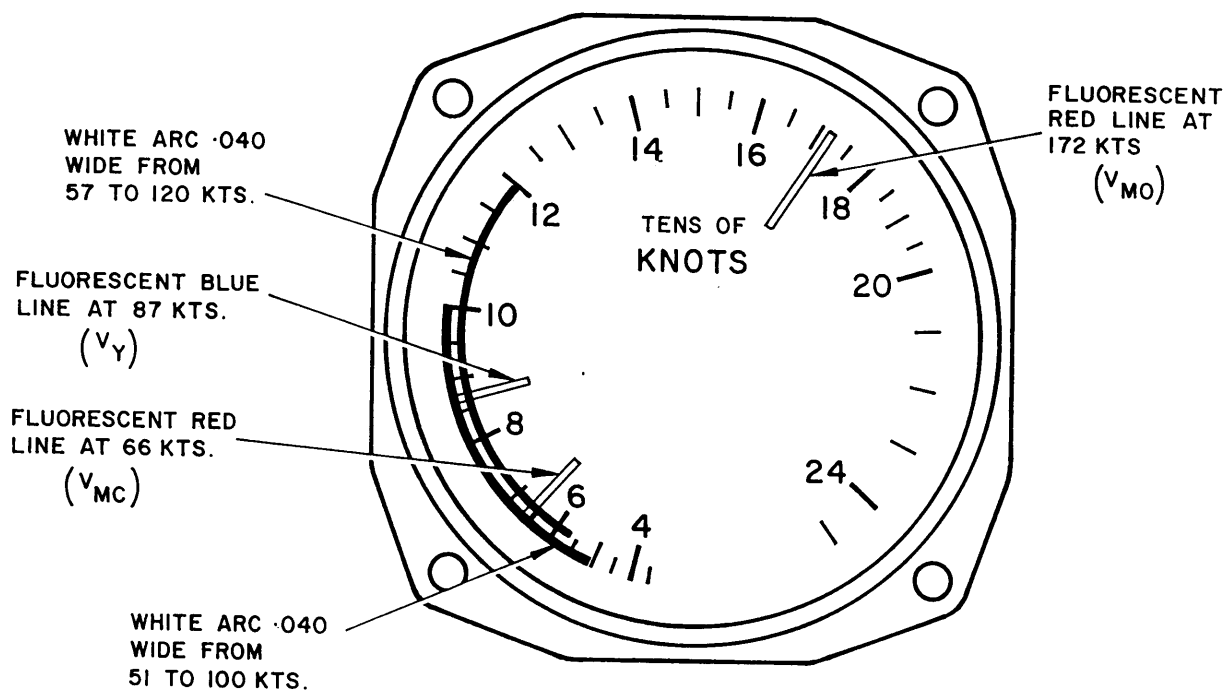
FIG. 2

(2) V_{MC} is updated from 62kts to 66kts for N22B aircraft only.

N22B aircraft will have ASI dials red radial at 62kts remarked at 66kts.

ASI FOR N22B PART N° 2/N-80-442 OR EA-5173-(6)-GAF

Replace with the new, overhauled, repaired or reworked unit which has dial markings conforming to Figure 2. The replacement unit is identified by P/No. 2/N-80-442 or EA-5173-(6)-GAF.

NOTE: 2 ASI with dials reworked to Figure 2 by G.A.F. will be P/No. 2/N-80-442. ASI supplied by Edo-Aire ex factory will have marked P/No. EA-5173-(6)-GAF.

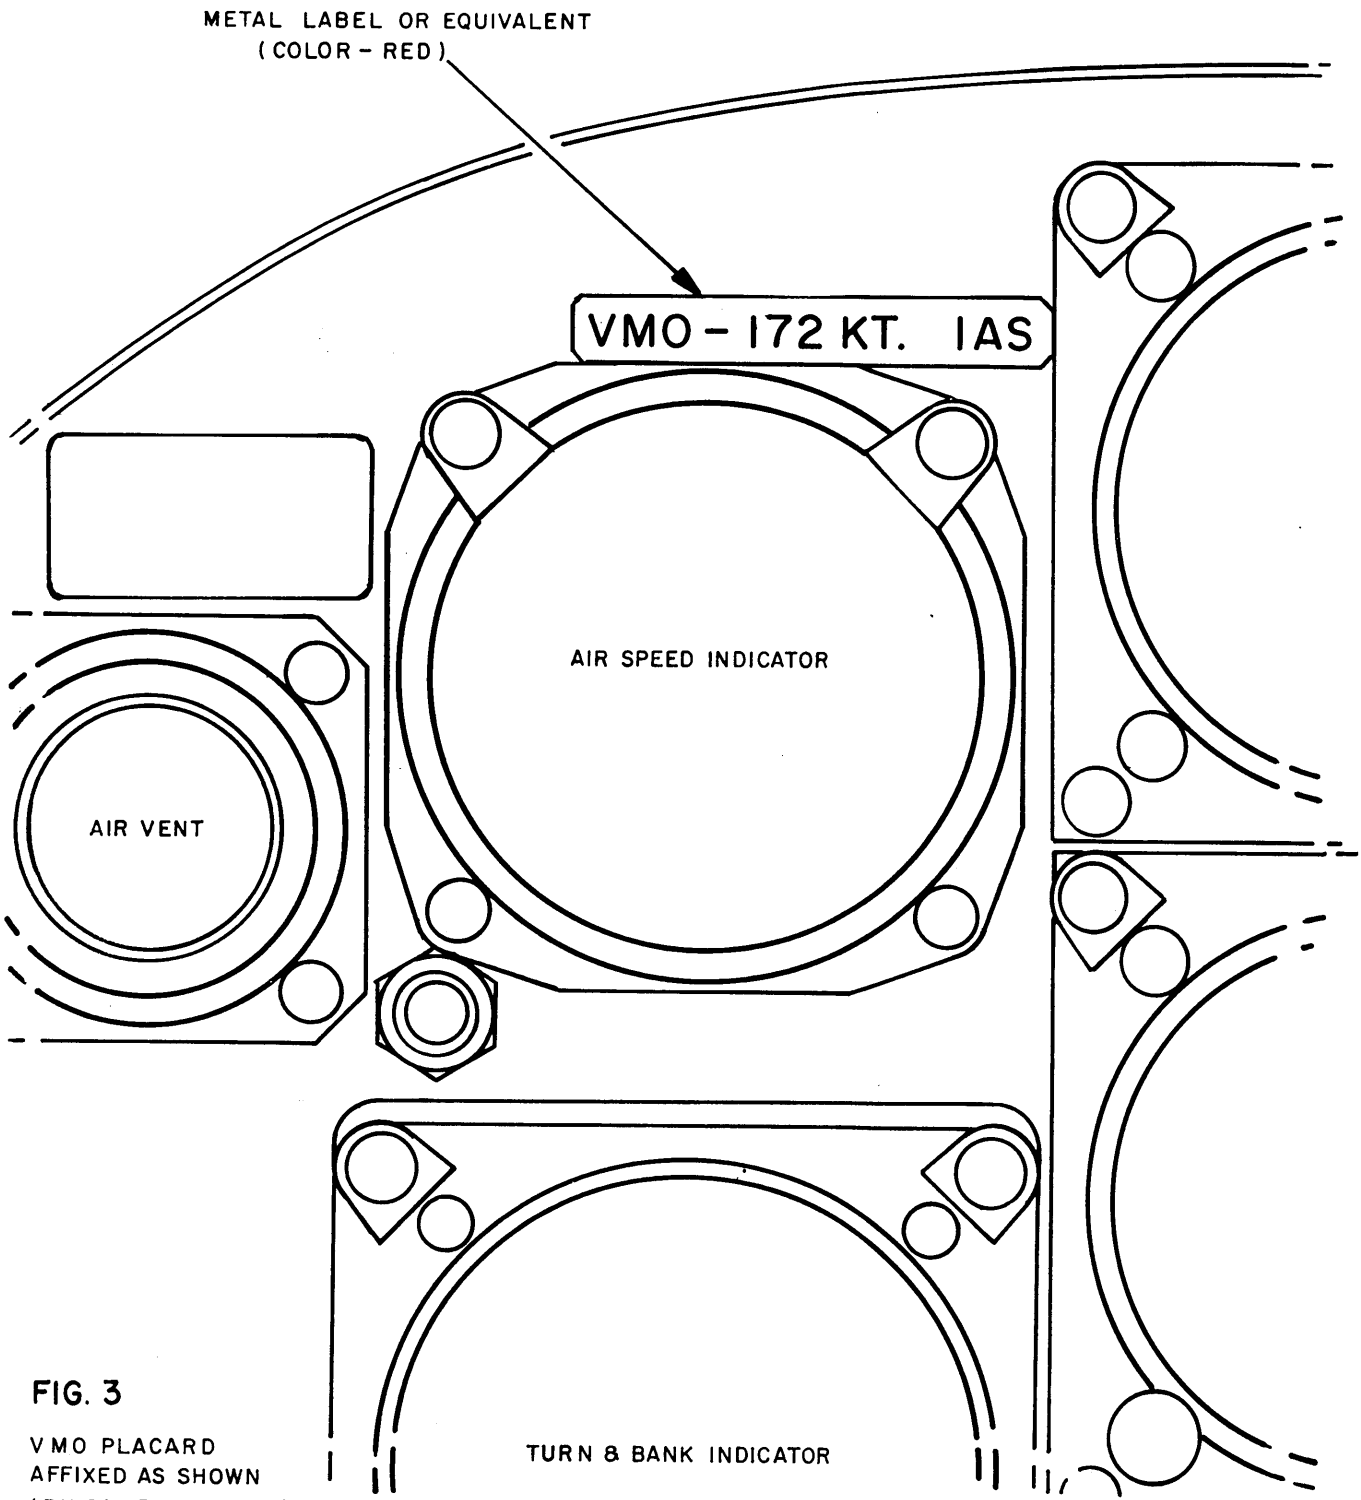
FIG. 3
VMO PLACARD
AFFIXED AS SHOWN
(RH PANEL SIMILAR)

- (i) Affix a placard with the caption as per Figure 3 adjacent to the L.H. ASI in location shown.
- (ii) When optional R.H. ASI fitted affix similar placard as item (i) above.

Part 1 Locally manufacture, as required, label from Metcal, scotchcal
(colour red) or suitable equivalent as per Figure 3.
