SUBJECT: INSTALLATION OF STOP BRACKET ON EMERGENCY EXIT DOOR OPERATING MECHANISM (MOD N495)

All Nomad N22-Series and N24-Series aircraft whose log books do not already record the embodiment of Mod N495 or compliance with Service Bulletin NMD-52-4.

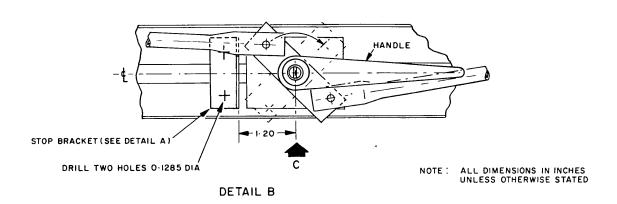
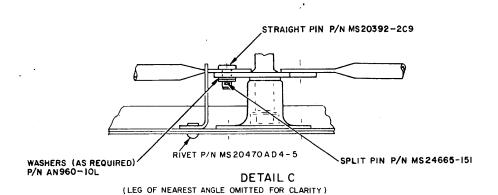
Manufacture and Installation of Stop Bracket (Mod N495)
Figure 1

Isolated instances have been reported in which the latch operating handle of an emergency exit door became incorrectly orientated, and the handle operating sense became reversed.

The problem is believed to be caused when the door trim is removed and the door operating handle is forcibly turned anti-clockwise beyond the fully closed position. When sufficient force is applied to the handle after the mechanism push-rods reach their mechanical stops, flexing of the door structure can allow the mechanism linkage to move to an over-centre condition. The door operating handle will then be 180 degrees from its normal attitude. If an attempt is then made to rectify the problem by simply removing, re-orientating and re-fitting the handle, the mechanism will operate in the wrong sense (tending to open the door when the handle is turned anti-clockwise, and to close it when the handle is turned clockwise).

A bracket is manufactured and riveted to the inside of the emergency exit door outer wall. The bracket limits the range of movement of the latch mechanism forward push-rod so that the linkage cannot be forced over-centre. The bracket also serves to prevent cross-connection of the forward and aft pushrods at the latch operating lever during maintenance or repair operations.

- A. Manufacture stop bracket P/N NMD-52-4-1 (Ref Figure 1, Detail A).
- B. Remove the emergency exit door from the aircraft (Ref MM 52-20-00).
- C. Remove the emergency exit door window panel assembly (Ref IPC 52-20-01 Figure 1 Item 4).
- D. Place stop bracket P/N NMD-52-4-1 in position (Ref Figure 1), mark its position, then use one of the holes in the stop bracket as a drill guide to drill a 0.1285 inch diameter hole in the door outer wall.

- F. Hold the stop bracket in the marked position against the inside surface of the emergency exit door outer wall and align the previously-drilled hole in the door panel with the corresponding hole in the stop bracket. Using the other hole in the stop bracket as a drill guide, drill a second 0.1285 inch diameter hole in the door outer wall.

- G. Rivet the stop bracket to the emergency exit door outer wall using two rivets P/N MS20470AD4-5 or equivalent.
- H. Re-assemble the latch mechanism forward push rod to the operating lever using the original straight pin and washer (Ref Para 2.E) add additional washers P/N AN960-10L as required to eliminate end float in the straight pin then secure with a new split pin P/N MS24665-151.
