SERVICE BULLETIN NO: NMD-52-7

DATED: 9th February, 1990

Doors - Aft Passenger Door - Improved Mechanical Stop

(Modification N638)

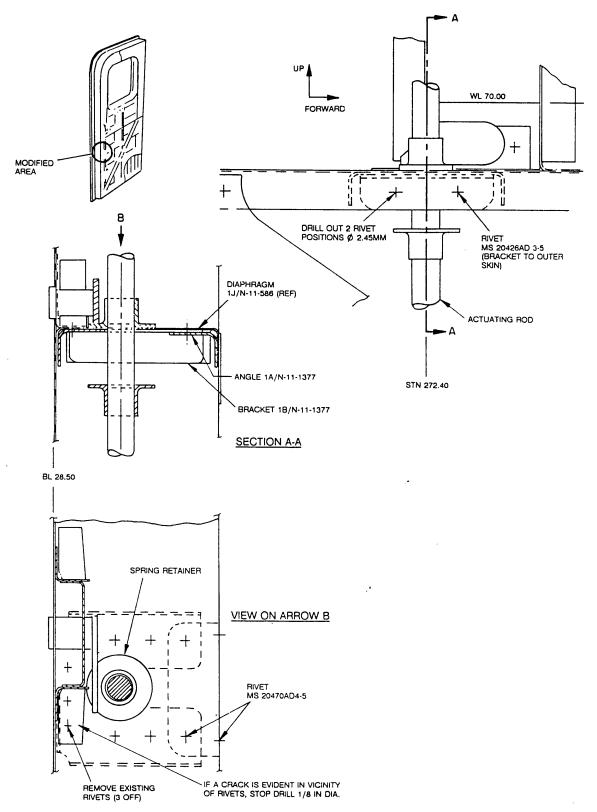
Re-Inforcing of Aft Passenger Door Figure 1

The under side of the diaphragm is strengthened by the addition of a re-inforcing bracket and angle.

- A. Remove the lower trim from the passenger door.
- B. Drill out the two rivets as shown in Figure 1 View on Arrow B. Inspect area around rivet holes for any signs of cracking. If the area is cracked, stop drill using a 1/8 in dia drill.
- C. Make a bracket 1A/N-11-1377SB and angle 1B/N-11-1377SB as shown in Figs 2 and 3 respectively.
- D. Position the bracket and angle and, using the bracket and angle as templates, drill rivet holes in the diaphram and door frame with a #30 drill. Using a  $\oint$  2.45 mm drill, drill out two rivets from the outer skin to match the bracket as shown in Figure 1. Deburr all holes.
- E. Rivet bracket and angle to diaphram using MS20470AD4-5 rivets. Rivet bracket to outer skin using MS20426AD3-5 rivets and angle to door frame using MS20470AD4-5 rivets.
- F. Clean all swarf from inside door. Alodine and epoxy prime any bare metal.
