# SERVICE BULLETIN

SUBJECT: INTRODUCTION OF FIBREGLASS RUDDER TIP FAIRING

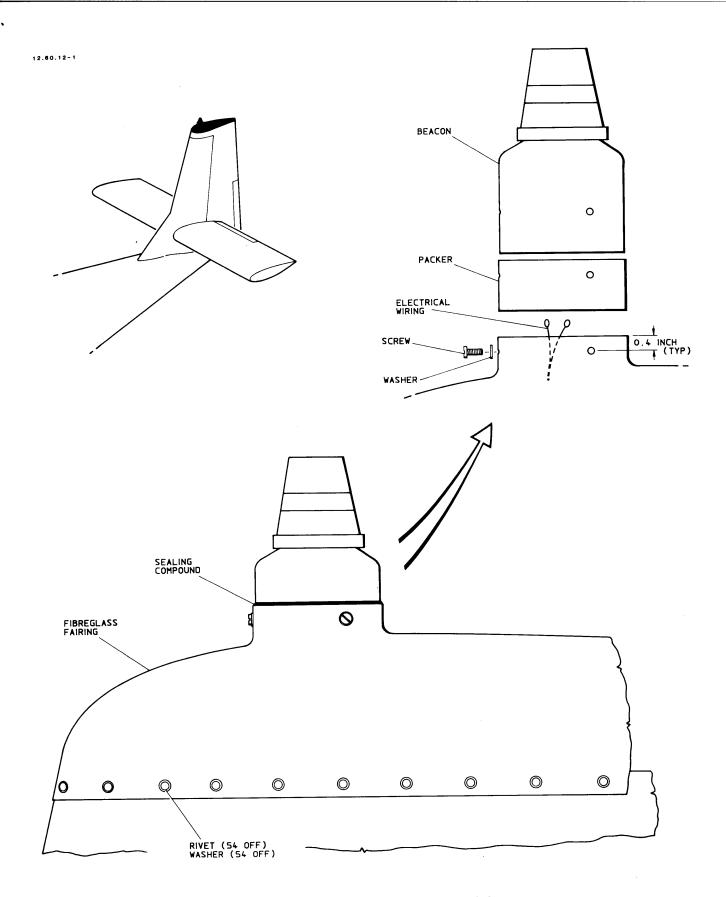
Installation of Rudder Tip Fairing
Figure 1

Following some reports of cracks in the ABS plastic material at the beacon mounting location a stronger fibreglass rudder tip fairing is fitted.

- A. Remove the rudder from the aircraft (Ref MM 55-40-00).
- B. Remove the rudder tip fairing (Ref Figure 1)
  - (1) Remove the anti-collision beacon (Ref MM 33-40-00).
  - (2) Drill out the 54 rivets retaining the rudder tip fairing to the rudder tip. Remove and discard the fairing.

- C. Fit the fibreglass rudder tip fairing
  - (1) Locate the fibreglass rudder tip fairing on the rudder tip. Using a hole locater and a No.30 (3.30 mm) drill, drill the 54 holes in the rudder tip fairing using the existing holes in the rudder tip mounting flange as a guide.

- (2) Using a 5/32 inch (4.0 mm) drill, drill one hole in the front of the beacon mounting flange on the rudder tip fairing 0.4 inch from the top edge. Using one of the pre-drilled holes in the packer P/N 1A/N-03-679, attach the packer to the inside of the beacon mounting aperture with a service bolt, or other suitable fastener. Drill the remaining two holes through the packer (pre-drilled) and the fairing using the packer as a drill guide.

- (4) Refit the fibreglass rudder tip fairing to the rudder tip and rivet up using rivets P/N CR3223-4-2 and washers AN960-PD4. The washers are installed under the heads of the rivets.

- (5) Reconnect the electrical wiring to the beacon and then install the packer and beacon into the aperture in the rudder tip fairing with the three screws and washers removed in Para 2A.(1).

- (6) Clean the area around the joint between the beacon, packer and fairing with petroleum ether and, when dry, seal with a fillet of PR 1422-B2 or suitable alternative. Remove surplus sealant before it cures using a soft cloth soaked in petroleum ether.
