# TRANSMITTAL LETTER FOR SERVICE BULLETIN NMD-55-29

#### STABILISERS — HORIZONTAL STABILISER — PIVOT BRACKET BUSH REWORK

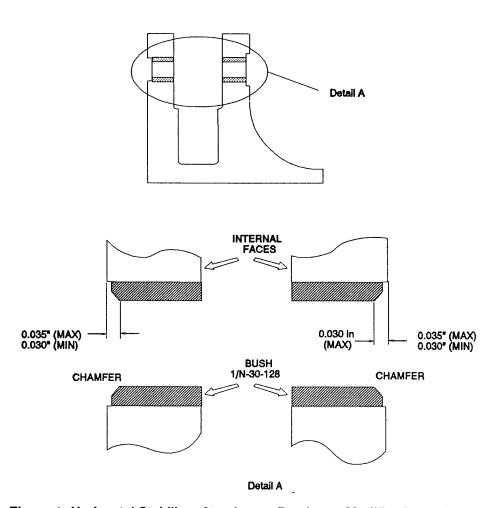
Figure 1 Horizontal Stabiliser Attachment Brackets - Modification to Bushes

The Pivot Bolt PN 2/N-00-44 has a machined radius between the bolt shank and the bolt head which may interfere with Pivot Bracket PN 1/N-30-127.

- A. Inspect Bushes PN 1/N-30-128 to determine whether the internal faces are flush with the internal faces of Pivot Bracket PN 1/N-30-127 (Ref Fig 1). If bushes are flush, proceed to step B. If not, proceed as follows:
  - (1) Assemble Pivot Bolt PN 2/N-00-44, a sleeve of suitable length and diameter slightly less than that of the bush and a large flat washer to the pivot bracket as shown in Figure 2.
  - (2) Slowly tighten nut until the internal faces of the bush and lug are flush.
  - (3) Repeat for remaining bushes as required.
- B. Use a 90° angle countersink tool or countersink mini-grinder in a suitable hand tool to remove up to 0.030/0.035 in of material in accordance with Figure 1.
- C. Coat the worked area using CAD brush plating or pigmented varnish to prevent corrosion.
- D. Identify the reworked bush by applying a small dot of red lacquer on external faces of bush.
