WINGS - DEACTIVATION OF DE-ICE AND OTHER SYSTEMS

To remove all external items of Customer Options G18 and G99, and some internal components, and return the wing configuration to normal N22B standard.

Record compliance with Service Bulletin NMD-57-20 in the Airframe Log Book.

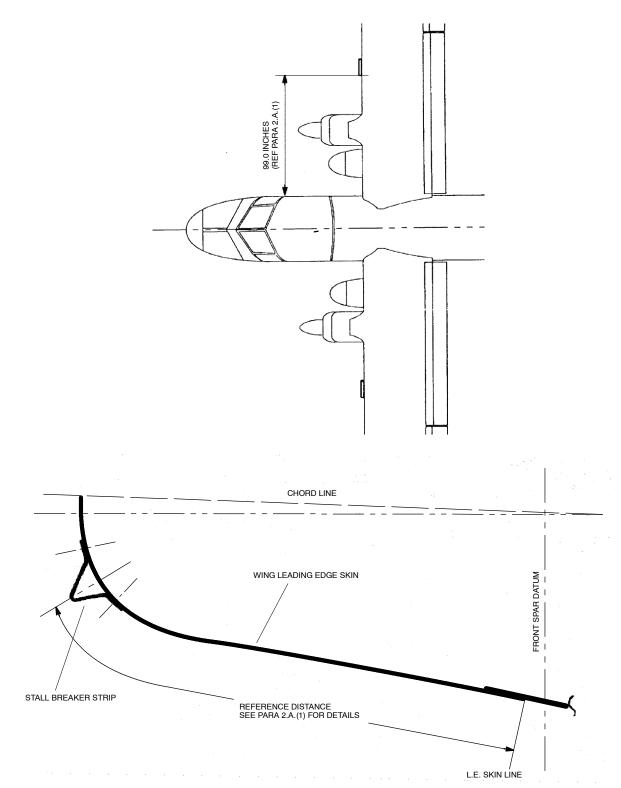
Figure 5 View Showing Stall Breaker Strip Location

- (1) For reference the inboard edge of the Stall Breaker Strip is at wsta 99.0 in (Ref Fig 5 and the position of the apex of the Strip on the leading edge of the wing is 10.4 in forward of the leading edge skin line (Ref Fig 5).

- (2) A new Stall Breaker Strip (Part Number 1M/N-20-610) should be offered up to the RH wing leading edge in as near as possible to the measurements taken above, and attached with double-sided adhesive tape. The object being to position the apex of the new metal Stall Breaker Strip as near to the position of the rubber Stall Breaker Strip.
