Government Aircraft Factories

**NMD-71-5
Revision 1**

SUBJECT: NOMAD SERVICE BULLETIN NMD-71-5 REVISION 1

SUBJECT: ENGINE NACELLE LOWER COWL - REPAIR

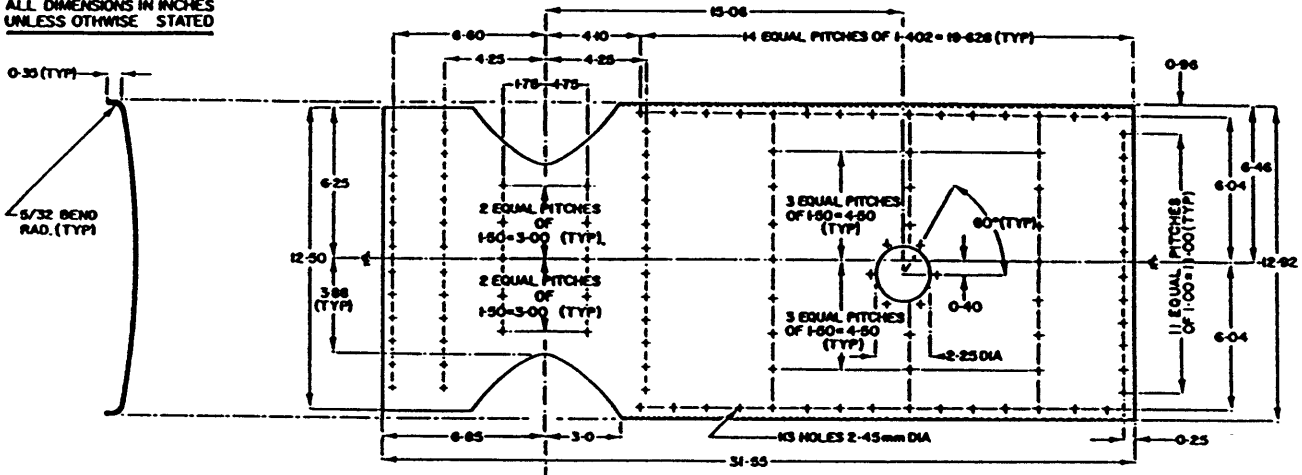
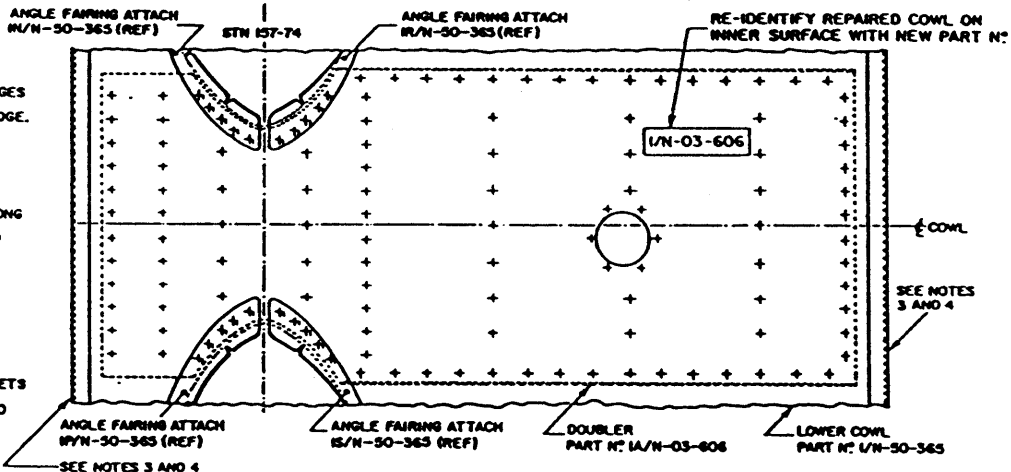
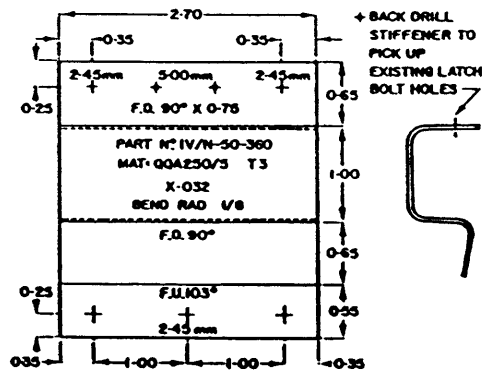
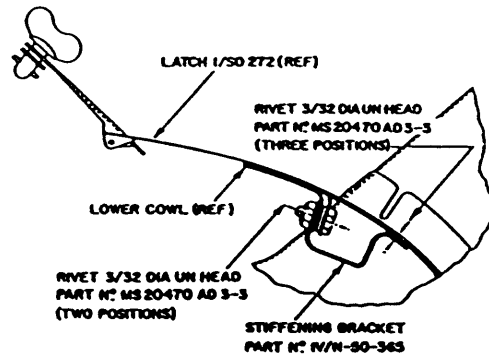
LOWER COWL ASSEMBLY
REPAIR SCHEME
FIGURE 1

In service cracking of the lower cowl has been reported.

Repair of the cowls is to be carried out as required, but as the cracking is vibration induced it is recommended that the cowls have this repair scheme incorporated at the next opportune aircraft servicing.

- (3) Fabricate the doubler P/N 1A/N-03-606 and the stiffening brackets P/N 1V/N-50-365 (Ref Figure 1) and paint with epoxy primer (Ref Service Letter 78-14).

- (4) Degrease the cowl and the exhaust stack.
 - (5) Fit and rivet the doubler to the inside of the cowl (Ref Figure 1).
 - (6) Refit the exhaust stack removed at step (2).

- 1 STRIP PAINT FROM LOWER COWL 1A/N-30-363 FRONT AND REAR EDGES A DISTANCE OF 0-625 FROM THE EDGE.
- 2 REMOVE SHARP EDGES.
- 3 APPLY BROUILLET N°4 EDGING ALONG THE FULL LENGTH OF FRONT AND REAR EDGES.
- 4 ADHERE WITH PR1421 OR PR1422 SEALANT.
- 5 DOUBLER TO PICK UP EXISTING RIVETS WHICH ATTACH ANGLE FAIRINGS TO LOWER COWL.
- 6 POSITION DOUBLER 1A/N-03-606 CENTRALLY AS SHOWN.

- 7 RIVETS: + = PART N° MSD20470AD3-3
4 = PART N° MSD20470AD3-4
- 8 O/S RIVETS MAY BE USED PROVIDING THE EDGE DISTANCE FROM CENTRE OF HOLE IS EQUIVALENT TO TWICE THE DIAMETER OF THE RIVET.
