SERVICE BULLETIN NO: NMD-76-1

TITLE: Engine Controls - Strengthened Condition Lever Linkage  
(Modification N610)

ENGINE CONTROLS - STRENGTHENED CONDITION  
LEVER LINKAGE  
(MODIFICATION N610)

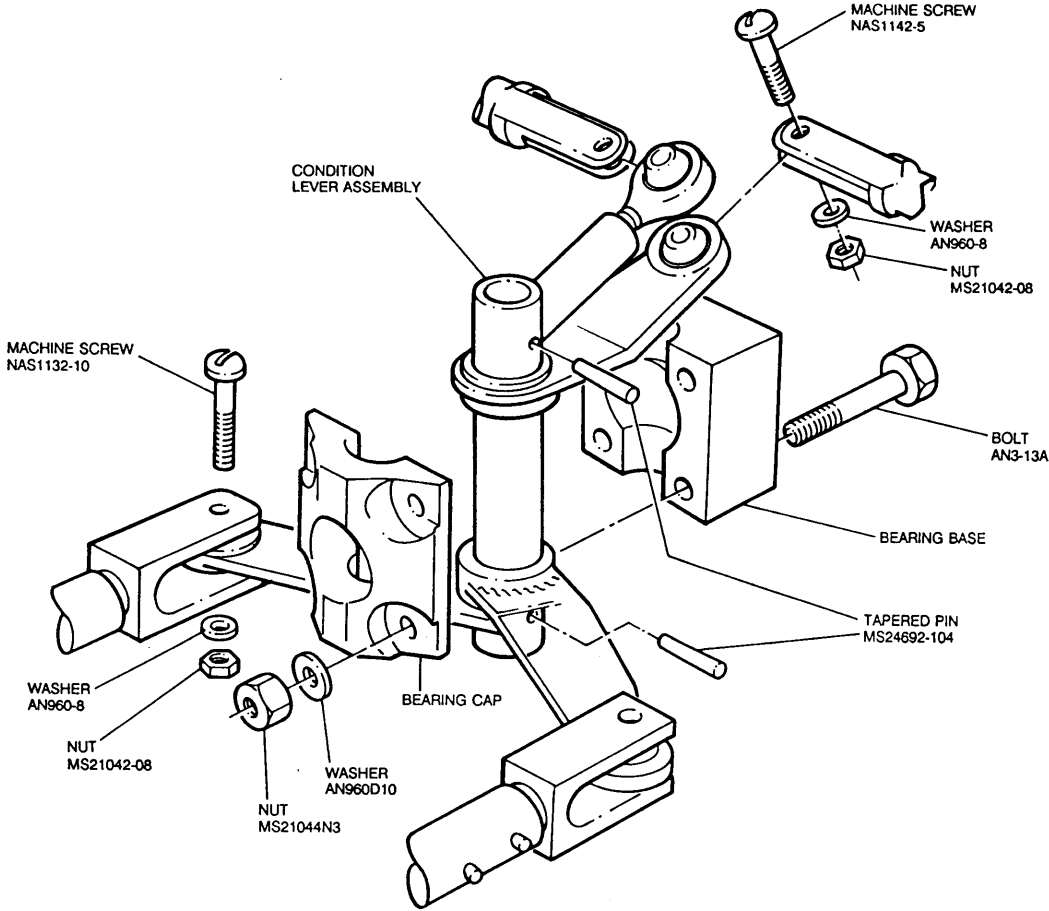
Installation of Condition Lever Assembly  
Figure 1

Should a malfunction occur that causes binding in the condition lever linkage, it is possible for the pilot to exert excessive shear loads on the tapered pins in the condition lever assembly.

The two 3/32 in. dia. tapered pins securing the lever assemblies to the spindle of the condition lever assembly, are replaced by 1/8 in. dia. tapered pins.

- A. Remove the condition lever assembly as detailed in MM chapter 76-10-20.
- B. Remove the tapered pin at the top of the condition lever assembly.
- C. Drill and ream condition lever assembly to suit new tapered pin MS24692-104. Carefully drive the tapered pin into the hole and, supporting the larger end of pin, peen the smaller end.
- D. Remove the tapered pin at the bottom of the condition lever assembly and repeat sub-para C. above.
- E. Check that the levers rotate freely before installing the condition lever assembly as shown in Figure 1 and detailed in MM chapter 76-10-20. Fit new lock nuts to the bearing block bolts and to the machine screws for the clevis end and push rod end fittings.
