SB-GA8-2005-23

Issue 8

Service Bulletin

Forward Cargo Door Slide

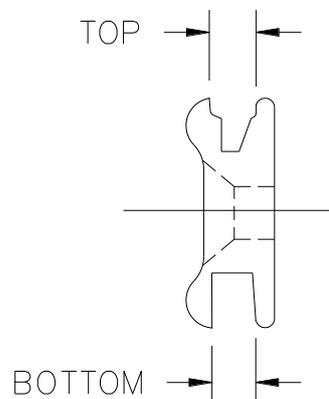
4. Figure 3 shows how a worn part normally looks and where to measure the groove width. The TOP and BOTTOM profile differs on a worn part and as such both the top and bottom slide grooves are to be measured with a calliper.

Figure 3: A worn slider indicating where to measure.

5. Measure the groove width and if the groove is wider than 0.145" at any point along the slider, or if the part is cracked or excessively worn, a new slider, Item 1, must be fitted.
6. Irrespective of Item 1, Items 2 to 7 MUST be fitted as shown in Figure 4 and listed in Table 3.

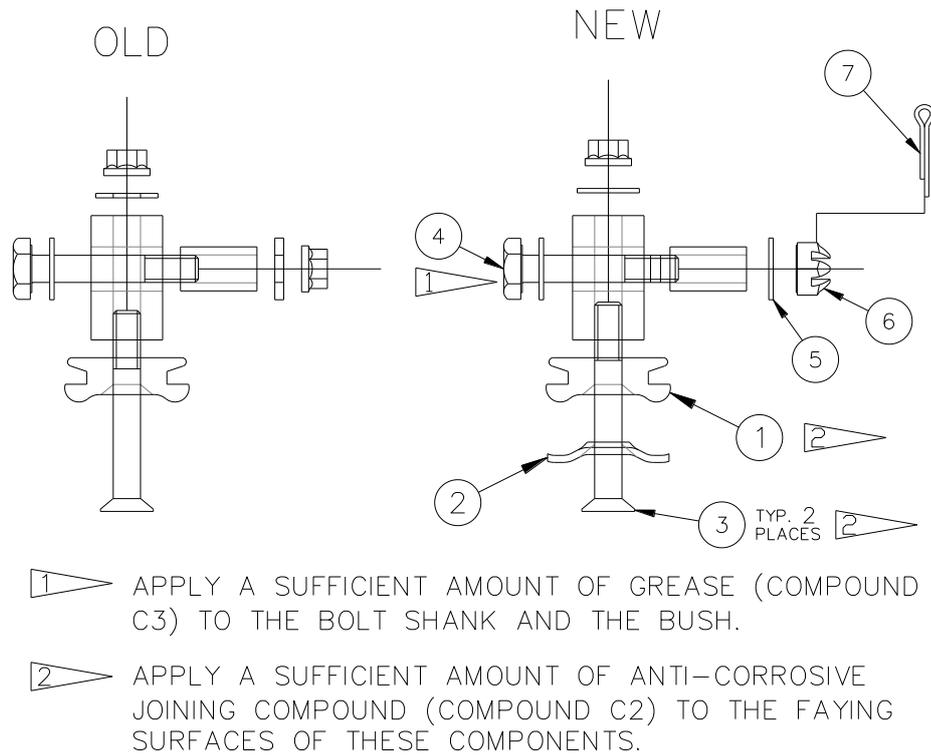
Figure 4: Old (left) and New (right) Forward Cargo Door Guide Assembly.

7. Reinstall the new slider assembly and refit the Nylon Track End if it was removed. Note that the notch in Item 1 and Item 2 must be facing aft, refer to Figure 22 of **PART D1** for the correct installed orientation.

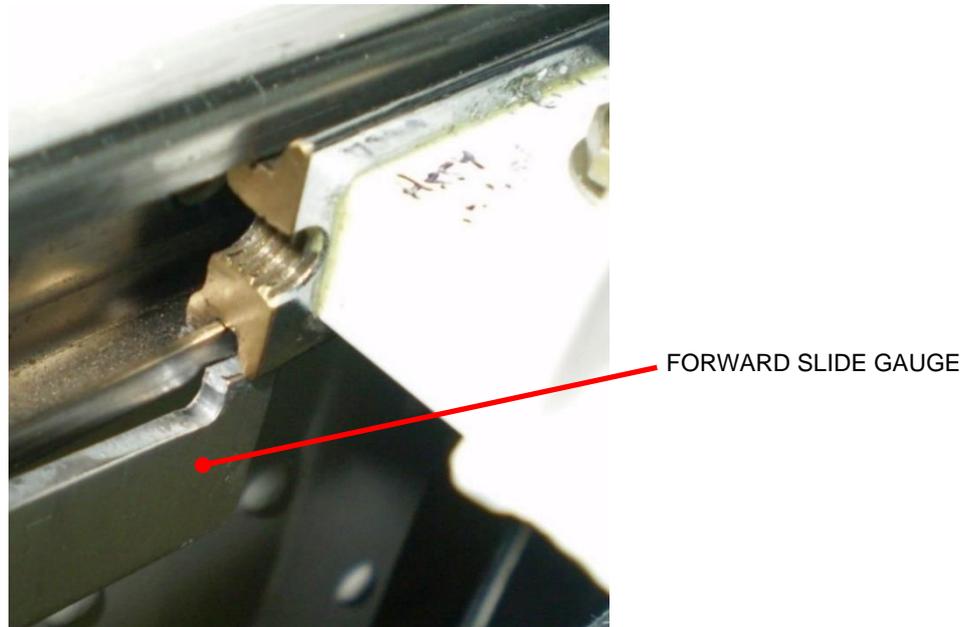
Figure 5: Checking with the Forward Slide Gauge. Note that all four corners require checking.

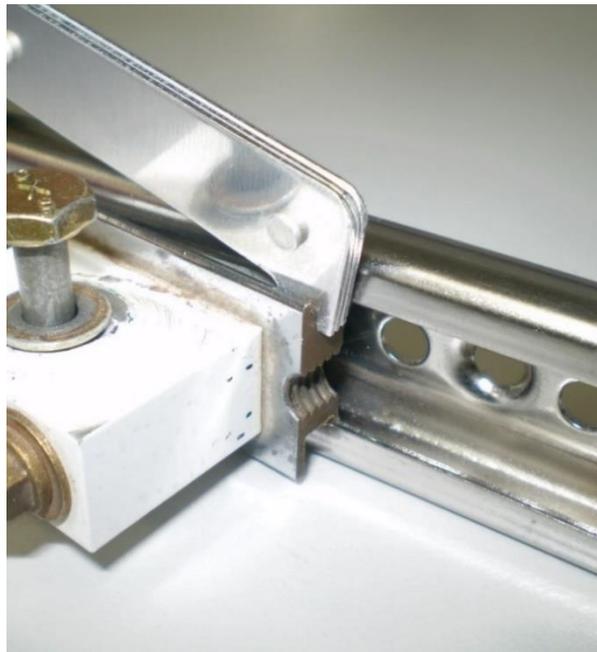
Figure 6: Forward Slide Gauge inserted between the slide and track, indicating a worn part. Note track in the image has been removed from the aircraft for clarity. Checking can be completed with the track installed on the aircraft.

3. If it is possible to fit the Forward Slide Gauge or feeler gauge between the track and slider (as shown in Figure 6 above) at any of the four corners carry out PART A1, Step 2 through 4.
OR
4. If Item 8 (or standard feeler gauge) is unavailable, carry out the inspection under PART A1, Step 2 through 4.

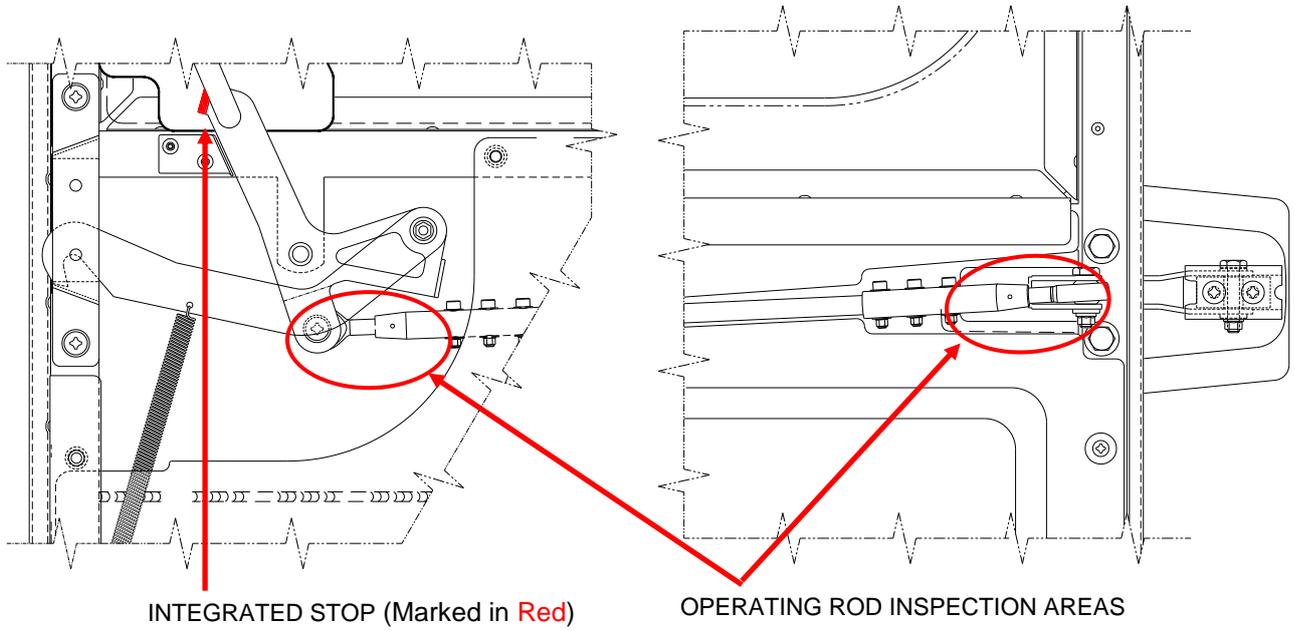
3. Inspect threaded studs and rod ends at both ends of the operating rod as shown in Figure 8. If there is any indication of bending:
 - i. For actuation rods fitted with female rod ends, do PART B3.

Figure 8: Rear Door Handle Mechanism - Inspection Areas.

- ii. For actuation rods fitted with male rod ends, replace the parts with new Item(s) 9-B, then repeat the inspections and necessary rectification actions detailed in PART B2 and B3.

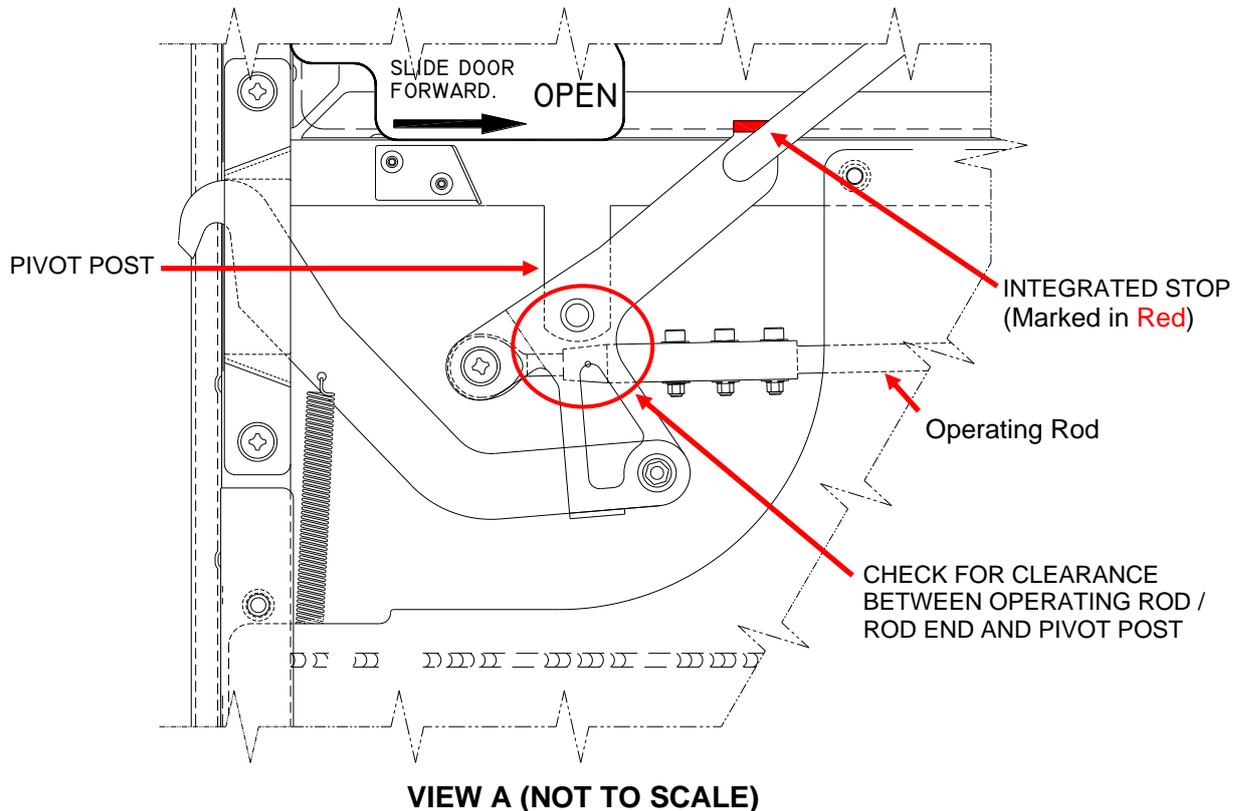
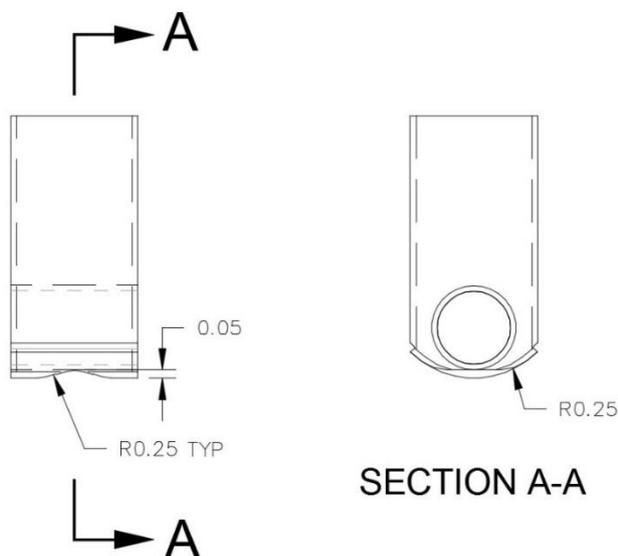
Figure 9: Rear Door Handle Pivot Post – Rework Area.

1. Remove the Rear Mechanism Cover by removing the screws marked in Figure 7.
2. With the door handle held fully open / against the stop, check that the operating rod does not touch the rear door handle pivot post, refer to Figure 9. If the rod does touch the pivot post, do PART B2.

1. Disconnect the rod ends from the handle and pivot arm. Remove the forward rod end and pull out the operating rod.
2. Rework the pivot post as detailed in Figure 9.
3. Install the operating rod through frame bush prior to installing forward Rod End. Install rod ends and connect to the handle and pivot arm.

1. Only Pivot post shown for clarity.
2. Rework using blending guidelines of AC43.13-1B Chapter 6 Section 7 and 10.
3. Ensure rod end and rod have a minimum clearance of 0.040in from pivot post.
4. Restore surface protection IAW Service Manual using compound C5 (Table 7).

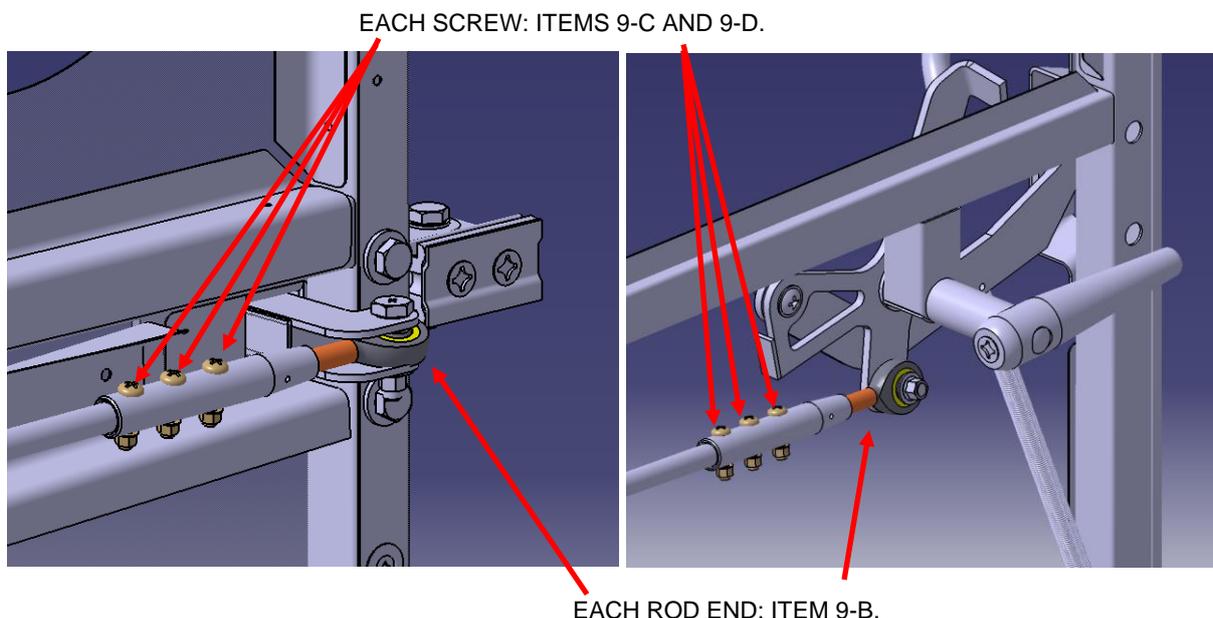
Figure 10: Rod End Fitting Installation FWD (Left) and AFT (Right). Some parts omitted for clarity.

- i. Cut 0.625 inches (15.9 mm) from each end of the existing Operating Rod.
 - ii. Temporarily fit the Rod, Fittings (Item 9-A) and rod ends (Item 9-B) to the door as shown in Figure 10.

- iii. Rotate the fittings so that the screws are vertical, as shown in Figure 10. Match-drill the rod to the Fittings (Item 9-A). Drill size #28 (0.1405 in).

- iv. Install screws, trim any excess thread below nuts and de-burr. Ensure 1.5 full threads extend beyond the nut.
 - v. Remove Fittings (Item 9-A) from the rod. Apply compound C1 and do the final assembly of the AFT Fitting (Item 9-A) as shown in Figure 10.

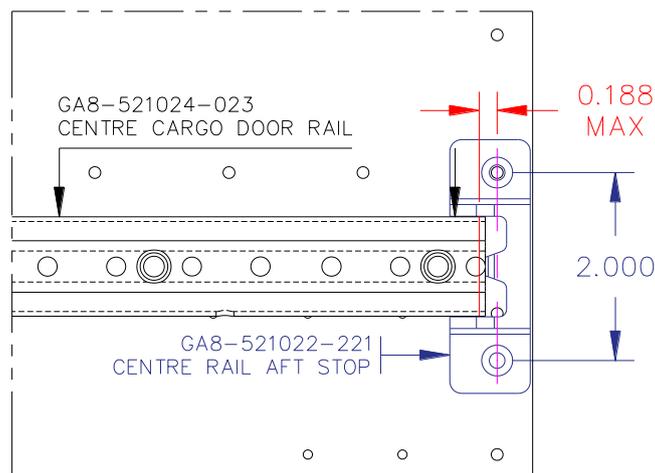
Figure 20: Maximum permissible trimming of the Centre Cargo Door Rail (GA8-521022-023). All dimensions are in inches.

6. Trial fit the Centre Rail Aft Stop. If the centre tapered feature of the component overlaps with the Centre Cargo Door Rail, it is permissible to trim (or notch) the aft end of the Centre Cargo Door Rail to the maximum dimension shown by the red trim line in Figure 20 (i.e. 0.188" forward of the Centre Rail Aft Stop attachment holes). If trimming the of Centre Cargo Door Rail is to be conducted in situ, it is recommended that a thin piece steel sheet is placed between the fuselage skin and the Centre Cargo Door Rail, to protect the aircraft's structure during trimming.

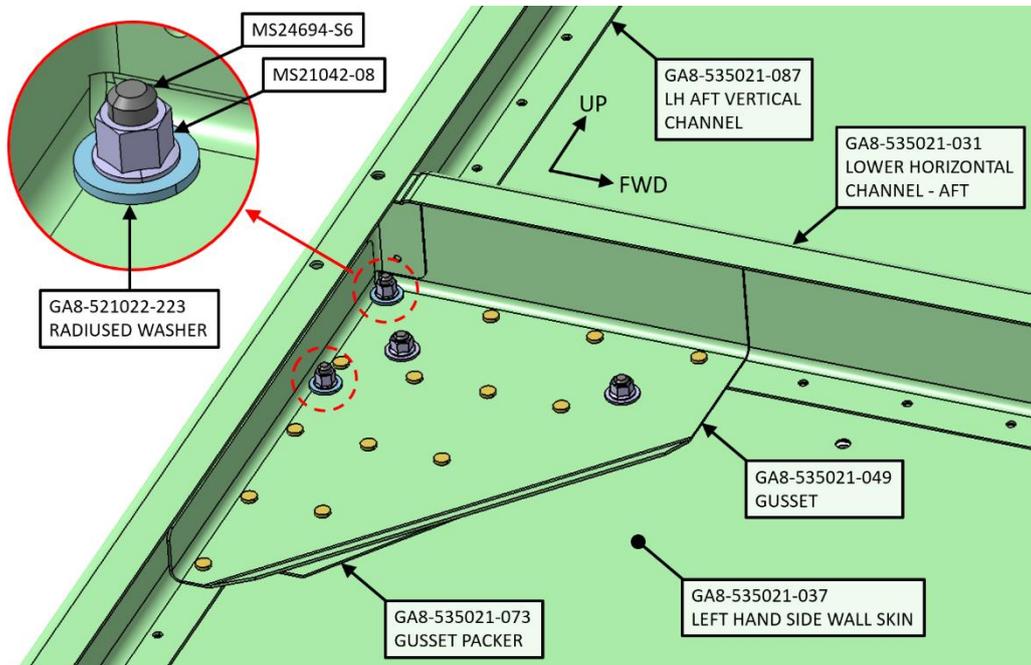
Figure 21: Installation of the Centre Rail Aft Stop (P/N: GA8-521022-221) component. View looking at the interior structure of the aircraft's port side fuselage wall.

8. Wet install the Centre Rail Aft Stop (P/N: GA8-521022-221) using two (2) off MS24694-S6 screws, two (2) off Radiused Washers (P/N: GA8-521022-223) and two (2) of MS21042-08 nuts as per Figure 21. A sufficient amount of anti-corrosive joining compound (Item C1 in Table 7) should be applied to the faying surfaces of the Centre Rail Aft Stop component the Left Hand Side Wall Skin (GA8-535021-037). Refer to Section 20-10-20 of the GA8 Service Manual for recommended torque values.

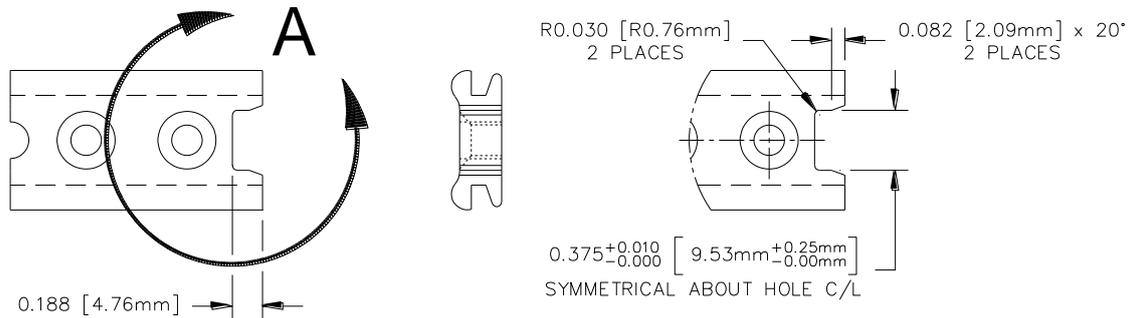
Figure 23: Machining of an existing Slide-Centre (P/N: GA8-521022-149) to form Modified Slide-Centre (P/N: SB-521022-225).

If the existing Slide-Centre (P/N: GA8-521022-149) component does not satisfy the requirements of PART A2, the slider is in an unacceptable condition and must not be used.

1. Modify an existing Slide-Centre (P/N: GA8-521022-149) component in accordance with Figure 23.

- NOT TO SCALE
- Unless otherwise stated, all dimension are in inches.
- Tolerances: Unless otherwise stated all dimensions are ± 0.005 " [0.13mm]
- De-burr sharp edges.
- Using indelible ink, permanently part mark the Modified Slide-Centre component as SB-521022-225.
