SB-GA8-2009-56

Issue 3

Service Bulletin

Overheating of overhead electrical connection used by cabin fresh air blower.

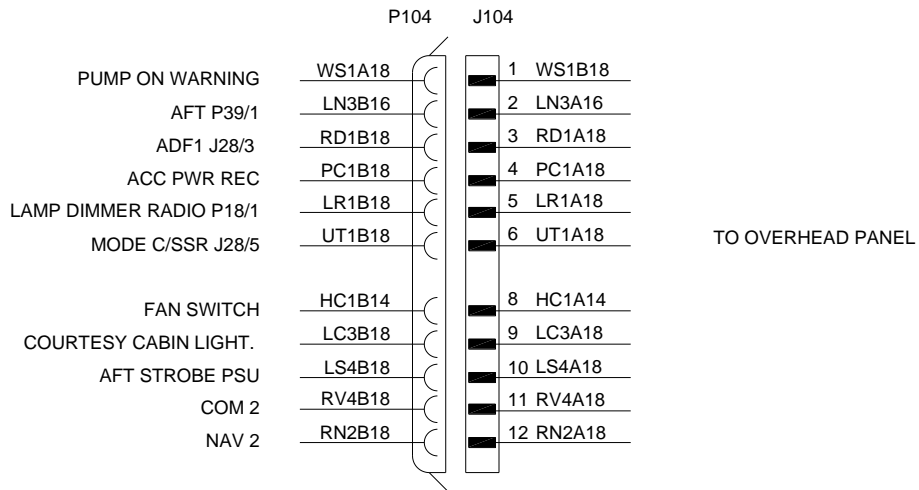
Figure 1: Connector P104 / J104

There have been some field reports indicating overheating of the connector plug J104/P104 at pin 8 between the aircraft wiring loom and the overhead electrical panel. Issue 3 gives a new, one-time, modification to address this issue.

- 1.1. Pull or open all the underfloor circuit breakers.
- 1.2. The affected connectors P104 and J104 are located port side just aft end of the electrical overhead panel. Remove the forward most centre interior roof panel to access the connectors.

- 1.3. Disconnect connector P104 / J104 and remove the blower fan circuits, HC1A14 and HC1B14 (Figure 1).
- 1.4. Inspect the existing 12-way P104 / J104 connector housing and replace if necessary, using Items 102 and 103 (Table 3). When replacing housing, mark Item J103 as "J104" and Item 102 as "P104" using a permanent marker.

- 1.5. Label Item 1 "J104B" and Item 3 "P104B" using a permanent marker.
- 1.6. Inspect the metal contact pin and socket for the blower fan circuits, HC1A14 and HC1B14 and replace with Item 104 and 105 if damaged or heat affected. Crimp tool HTR 11-01-0084 (Sargent Tools) is recommended for this task: Use nest B for 14 AWG wires. Install connectors to the housings at position 1.

- 1.7. Assemble connectors J104B / P104B and P104 / J104.
- 1.8. Close the underfloor circuit breakers and conduct functional tests of the blower fan.
- 1.9. Replace interior trim panels.
