SB-GA8-2011-82

Issue 2

Service Bulletin

Alcor CHT Probe and Extension Cable

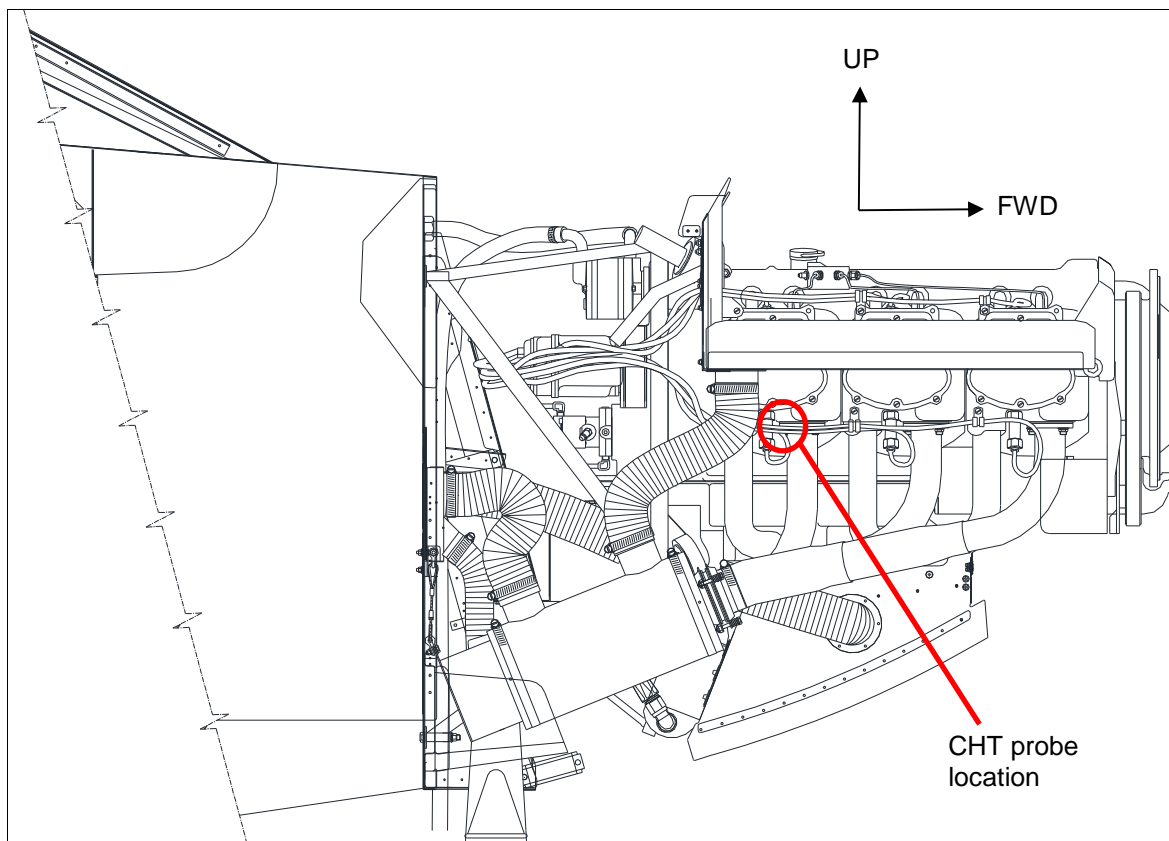
Figure 1 – Approximate Location for CHT Probe Installation. Viewed from RHS of aircraft.

3. Remove the existing GA200-772011-013 CHT Probe Assembly and the loom that connects to the CHT Indicator. See Figure 1 for CHT Probe location. Carefully remove sealant, as required, from the firewall to allow loom removal.

4. In the same location where the CHT probe was removed, fully insert replacement Bayonet Probe (Item 1) with the Alcor adaptor into thermowell, aligning locking pin with cap slot. Push and turn cap clockwise to lock.

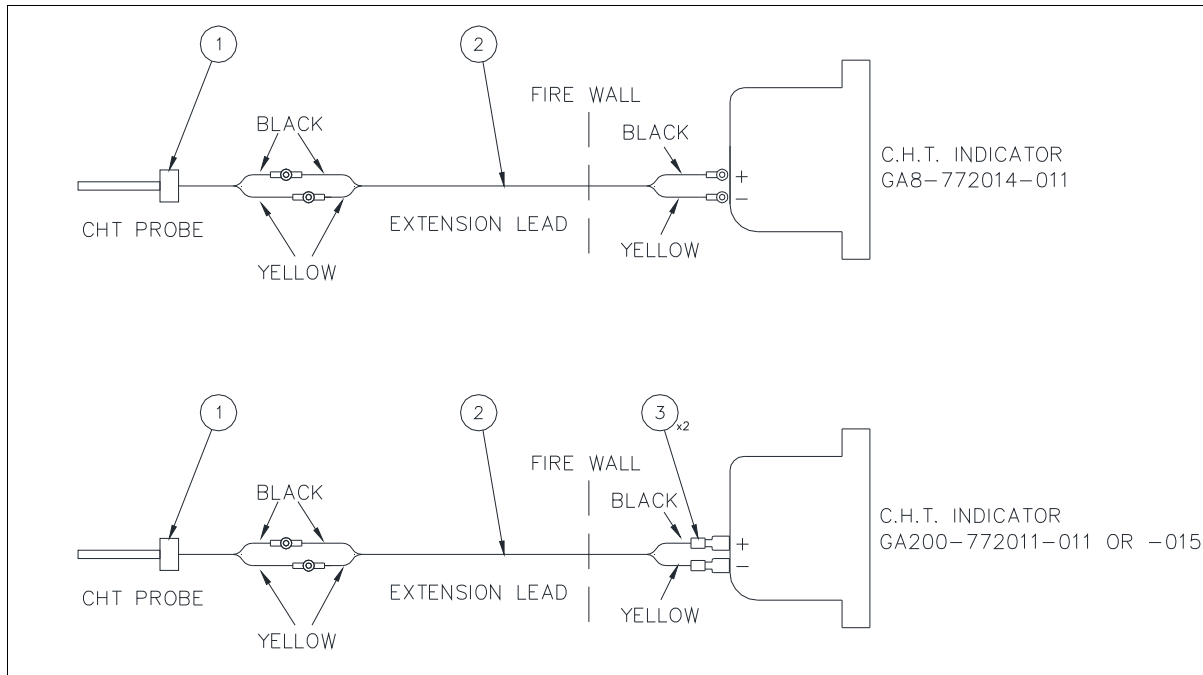
Figure 2 – Schematic diagram of CHT wiring.

5. Route the Extension Lead (Item 2) via the same path as the previously removed lead. The end of the Extension Lead which has a screw fitted, shall be located forward of the firewall. See Figures 2 and 3.
6. If the part number of the CHT Indicator is either GA200-772011-011 or GA200-772011-015, attach FIQC 1.25-6.4 DG terminal lugs (Item 3) to the ends of the Extension Lead which are aft of the firewall. This is not required if an Alcor Inc based CHT Indicator (GippsAero part number GA8-772014-011) is installed.
7. Attach to the extension lead to the CHT Indicator in accordance with Figure 2.

15. Attach the Extension Lead (Item 2) to the CHT Probe using screws already attached to the wires (see Figures 3 and 4) to fasten together the ring terminals. Refer to Figure 2 for wiring schematic.
16. Slide the supplied fiberglass insulation sleeve so that the connections between the Extension Lead and the CHT Probe lead are both covered.

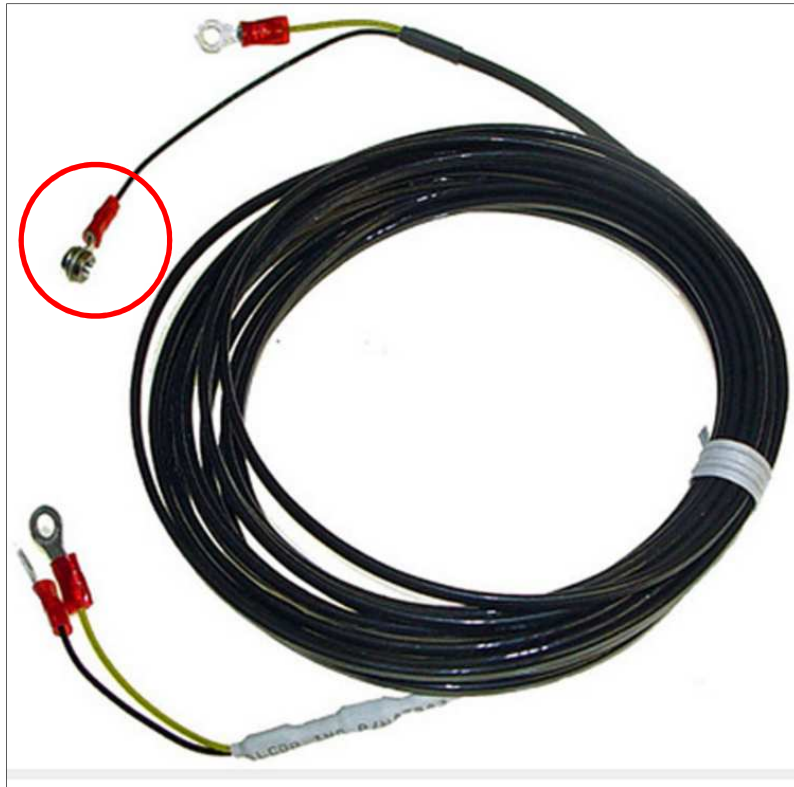
Figure 3 – Pictorial view of extension lead. Note screw fitted to black lead ring terminal (circled).

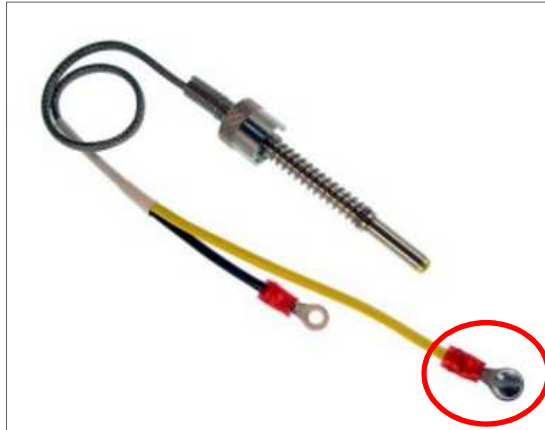
Figure 3 – Pictorial view of CHT Bayonet Probe.
Note screw fitted to yellow lead ring terminal (circled).
