SB-GA8-2014-116

Issue 3

Service Bulletin

Installation of a Secondary Starter Solenoid

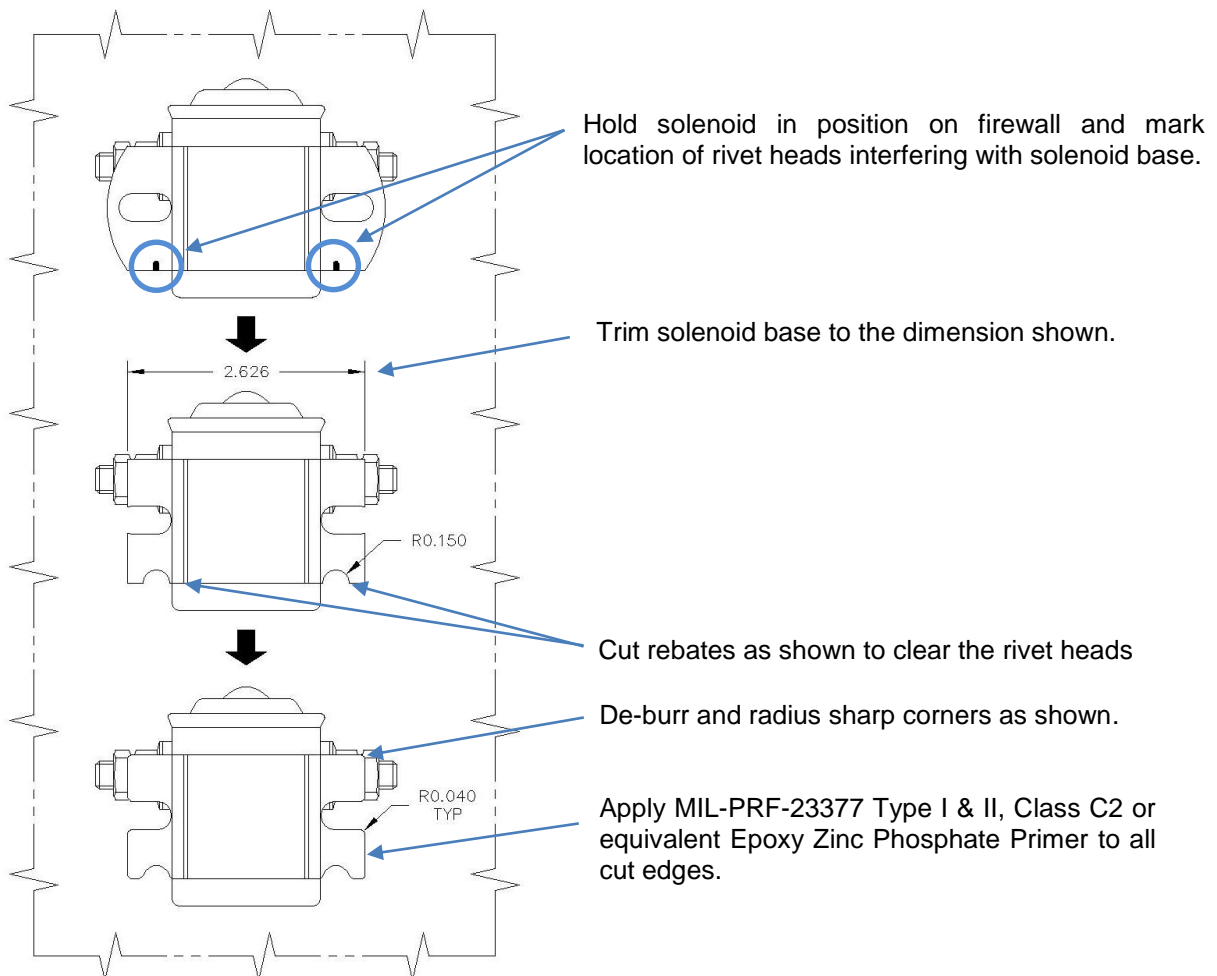
Figure 7: P/No. STS-S12 Solenoid Modification

12.2.5 P/No. STS-S12 solenoids made by “Lamar Technologies” have slightly different mounting plates which may impact the solenoid mounting bracket in some cases. Where this occurs, the solenoid may be modified as detailed in Figure 7 below:

12.2.6 The modified solenoid may then be affixed to the firewall in accordance with the details provided in Sections 12.1.10 through 12.1.13.
