SL-GA8-2017-33 Issue 1

# **Service Letter**

Exhaust System inspection.

GA8 model only. Not applicable to GA8-TC 320

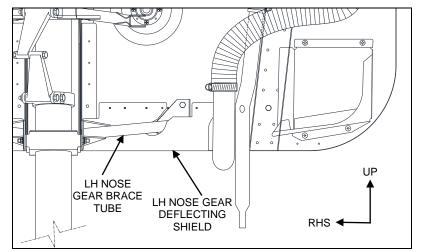
Figure 1 –Nose Gear Brace Tube and Nose Gear Deflecting Shield location. View of lower firewall looking aft. Exhaust system removed to aid clarity.

Cases of wear have occurred on the lower Nose Gear Brace tubes, and the adjacent Nose Gear Deflecting Shields, caused by contact with the Exhaust Ejector. Refer to Figure 1 for location. The instructions below detail inspections to ensure any potential wear issues are avoided. These are to be performed during each 100 hourly scheduled maintenance.
