SB-GA8-2001-01

Service Bulletin

Replacement of tailplane mount rivets with bolts.

GA8 all serial numbers up to and including GA8-01-007.

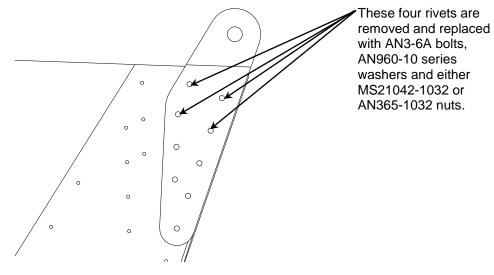
Figure 1

Service experience has shown the rivets which attach the rear tailplane attach brackets to the fuselage may work and fail.

- 2. Aircraft with more than 200 hours time in service and those required to comply with this action under action 1 must be modified by removing the top four rivets, drilling the holes out to 3/16" Ø and installing four AN3-6A bolts with AN960-10 series washers and either MS21042-1032 or AN365-1032 nuts. Ensure the correct thread engagement is achieved by the use of AN960-10 and AN960-10L washers as necessary.

3. Following modification in accordance with action 2 the attachment of the fitting to the fuselage must be inspected at every 100 hourly inspection for any signs of looseness, relaxing of the bolts, further working rivets or general damage. Any defects must be reported to Gippsland Aeronautics before further operation.
