SB-GA8-2005-25

# **Service Bulletin**

Remarking of	airspeed	indicator	white	and	green	arcs.

All GA8 aircraft up to serial number GA8-05-075.

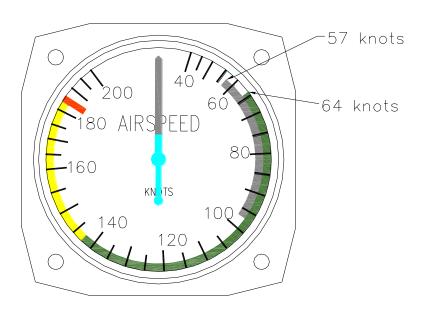
Figure 1 -Airspeed indicator marking

Additional flight testing of the GA8 to validate the calibration of the pitot-static system in slow speed flight near the stall has resulted in amended figures for indicated stall speeds. Accordingly the lower limits of the white and green arcs on the airspeed indicator (ASI) are required to be remarked. Note that the change of markings to the ASI has no affect on the stated indicated and calibrated airspeeds quoted in the Approved Flight Manual.

1. Remark the existing ASI (P/N GA8-341012-11) white arc to commence at 57 knots, and the green arc to commence at 64 knots. Refer to Figure 1. Re-identify the modified part as GA8-341012-15.

Alternatively, remove existing ASI and replace with new ASI (P/N GA8-341012-15).
