**SB-GA8-2008-47**

**Issue 4**

## Service Bulletin

Fuselage Skin Wear at Stabiliser Lower Fairing.

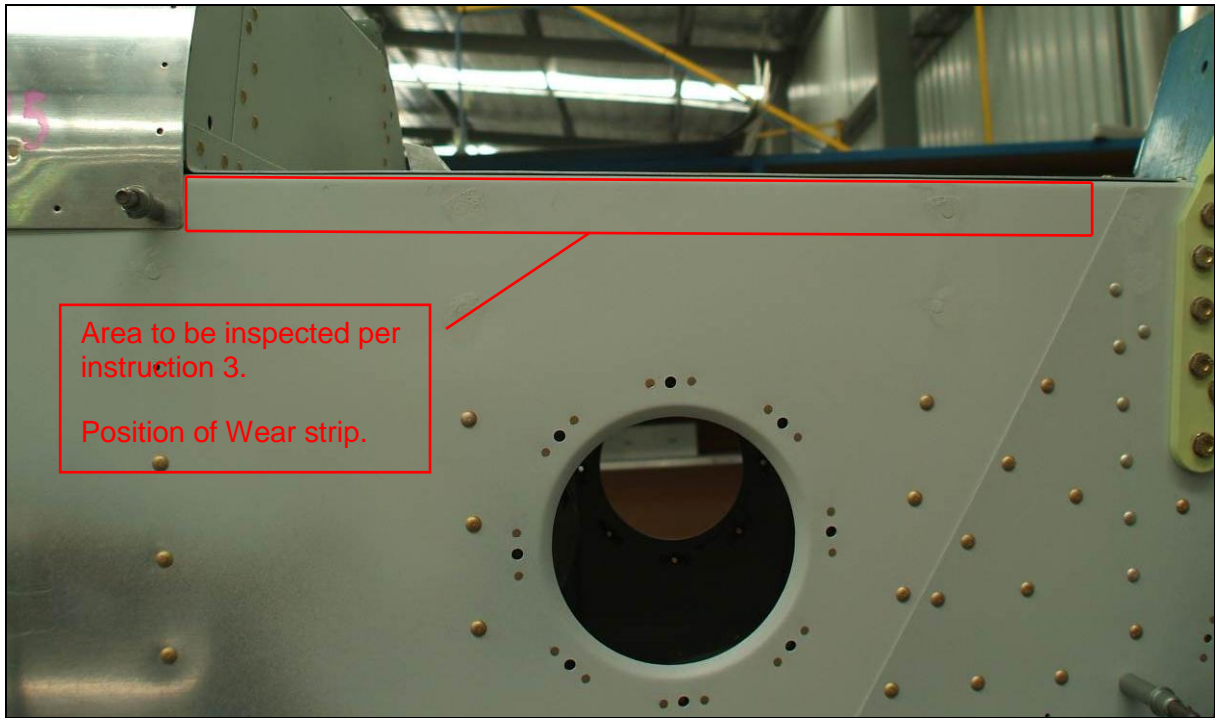
**Figure 1: Wear strip location**

Reports received from several operators indicate that a possibility exists where the gap strips attached to the lower side of the stabiliser can wear or chafe against the fuselage skin as the tailplane moves up and down during normal operation. Wear in this area can remain undetected during normal maintenance inspections due to the permanently attached tailplane gap strip covers. If this condition is left uncorrected severe wear to the fuselage skin can occur to the extent that repairs are required.

3. Clean and inspect the area shown in Figure 1 for any signs of wear. If the fuselage skin shows signs of wear other than removal of the paint finish or scuffing to the surface of the metal, or contains a crack that is no greater than 6" in length, implement the Repair Scheme defined below. If damage exceeds this amount contact GippsAero Pty. Ltd. with full details.

4. If no wear is present, position the two wear strips, GA8-538021-335, over the area shown in Figure 1 (LH side shown) and retain in position with adhesive tape. Mark the position of the holes then drill to 3/32-inch, clean and de-burr these holes. Prepare the area using a 240 Grade abrasive cloth then clean with a suitable solvent. Remove the protective strip from the back of each wear strip and apply a thin coating of 164G00002, (Pro-Seal 34 or Hysol EA9394 may be used as alternatives) to the back of each strip. Attach the strips using the MS20426AD3-4 countersunk rivets supplied. Ensure the strips are pressed firmly against the skin and that the wear strip remains flat. Remove any excess sealant. Adhesive tape or appropriate clamps may be used to hold the strips firmly in position until the sealant has properly cured.
