**SB-GA8-2011-75**

## Service Bulletin

Inspection of the upper tailplane gap strip LH/RH

All GA8 serial numbers

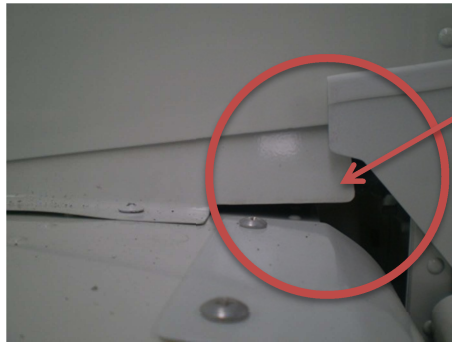
**Figure 2: Rudder Spar location**

During inspection, an instance was found of the upper tailplane gap strip contacting the fin front spar assembly, causing the gap strip to deform. If there is any interference, the fairing should be trimmed as outlined in this service bulletin.

Inspect this area (nose down – horizontal stabiliser position) to check the fairing does not interfere with the Fin front spar assembly – GA8-553011-19.
