SB-GA8-2014-114

Service Bulletin

Inspection for Correct Engine Mount Orientation

GA8 Normally Aspirated Aircraft Only

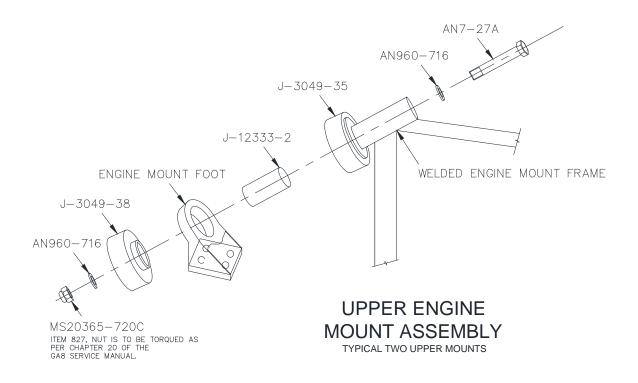
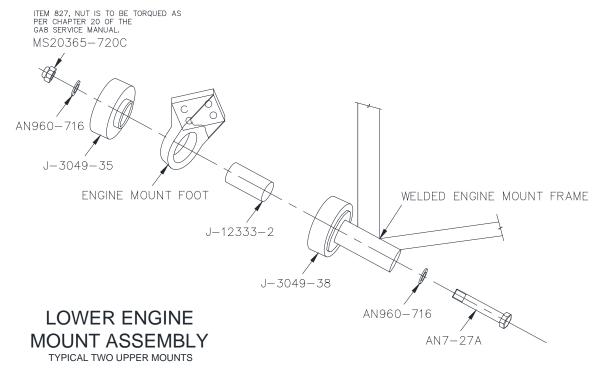
Figure 1: Engine Mount Assembly & Installation

Engine mounts on Naturally Aspirated Aircraft may have been installed with an incorrect orientation, due to the physical similarity of the sandwich mount components. The correct installation procedure is to install the stiffer mount on the compression side of the joint. This is predominantly to prevent premature mount deformation and subsequent engine sagging. Provided that correct bolt torque is maintained on the attachment bolt, the vibration properties of the engine installation will be unaffected.

- 1. Carry out the following procedure to inspect the rubber shock mounts on the GA8 aircraft.
 - 1.1. Remove the engine cowls.
 - 1.2. Inspect the mount components to ensure that they have been oriented as per Figure 1 below. Specifically, mount part no. J-3049-38 must be positioned on the compression side of the engine lug. For the upper mounts, this would be on the forward side of the engine lug and on the aft side for the lower mounts. The part number of the engine mount can be found moulded into the elastomer on the periphery of the mount. A depiction of the mounts is also shown in Figure 2. If any of the engine mounts are found to be not in accordance with Figure 1, proceed to step 2 otherwise skip to step 3

- 2.3. If the mounts are found to be unserviceable, replace the mounts with new parts.
- 2.4. Re-install the mounts ensuring that the mounts are oriented in accordance with Figure 1. Ensure the engine mount retention bolts are torqued to 450-500 in-lb per Chapter 20-10-00 of the Service Manual.
- 2.5. Inspect the cowls and engine installation for evidence of damage caused by excessive drooping of the engine. If damage is found, contact GippsAero for further assistance.
- 3. Re-install the engine cowls and proceed to the documentation section of this Service Bulletin.
