Service Letter

Nose Landing Gear Scissor Link Sleeve Corrosion.

All GA8 serial numbers.

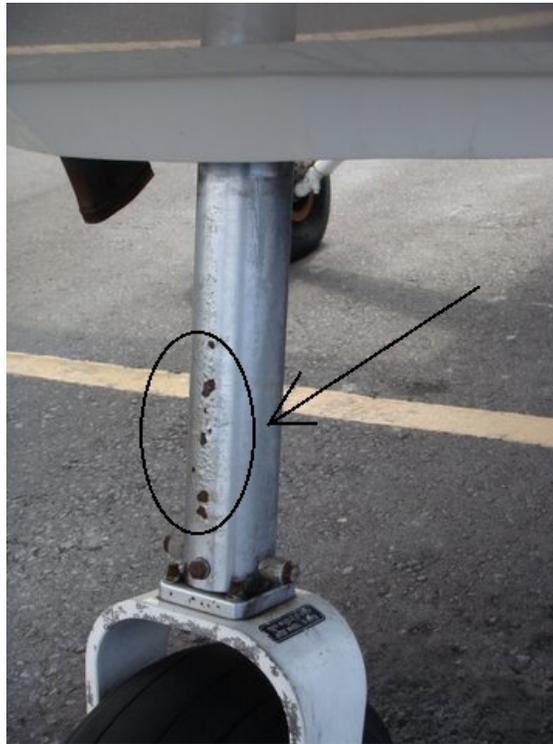
Figure 1

Corrosion can start in the steel tube below the chrome layer after stone chips penetrate the chrome finish. Corrosion will cause the chrome layer to blister and the corrosion will progress through and across the surface of the steel tube. Refer to Figure 1.

Any blister in the chrome layer is to be considered a corrosion spot.

Light corrosion is permissible providing that it does not exceed the following conditions :

- any single point larger than 3/4" (19mm) multiple joined points are not considered a single point.
- any corrosion in the area within 6" (150mm) of the lower sliding bearing, when the weight is removed from the NLG.
- any corrosion larger than 3/16" (5mm) within 3/4" (19mm) of the lower for joining block.

Minor corrosion spots may be removed in accordance with practices outlined in AC43.13-1B Chapter 6, Section 10.
