REPLACEMENT OF VHF COMMUNICATIONS ANTENNA (MODIFICATION N368 TO CUSTOMER OPTIONS G73, G73–24, G121, G121–24, G295 AND G295–24).

Any of the following aircraft whose log books do not already record the embodiment of Mod N368 or compliance with Service Bulletin NMD–23–3.

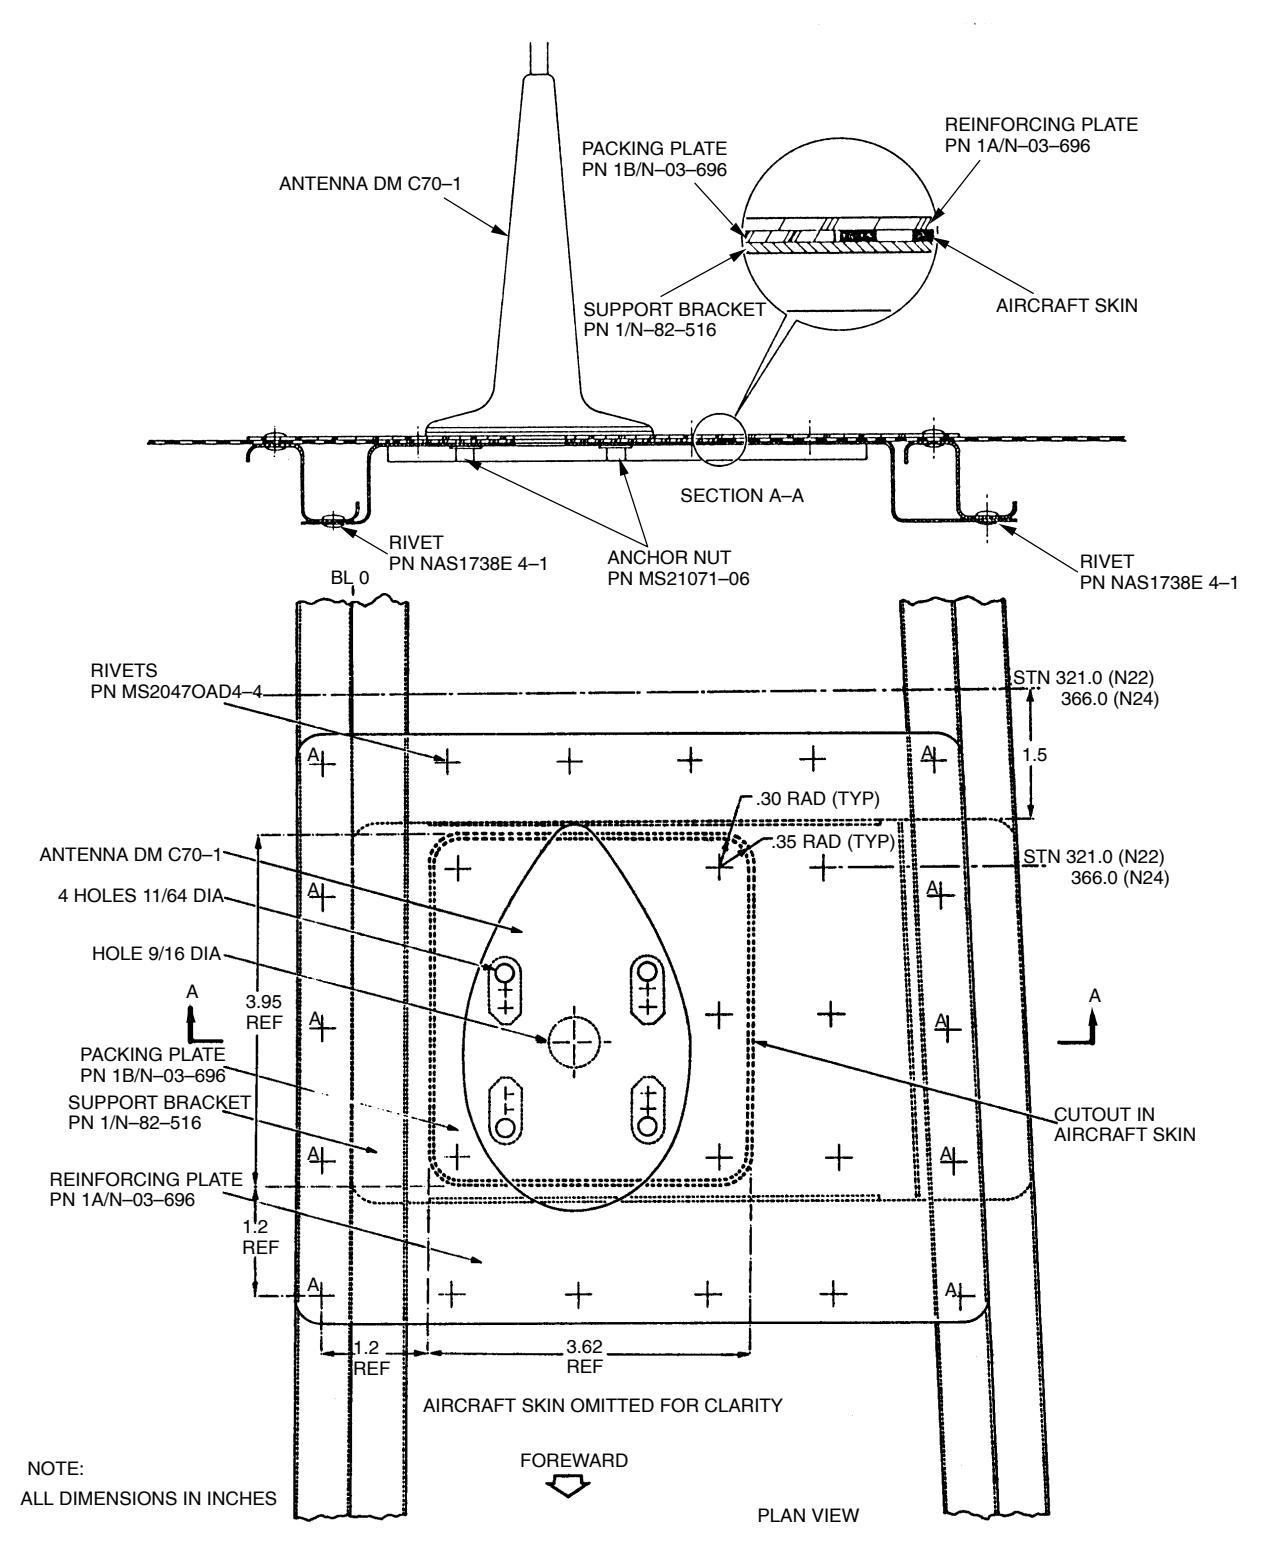
Figure 1 Installation of Mod N368

To prevent icing conditions adversely effecting the VHF communications antenna.

- D. Cut away the section of the aircraft skin as shown in Figure 1 and smooth the edges around the cut out.
- E. Manufacture the new support bracket PN 1/N-82-516 (Ref Figure 2), reinforcing plate PN 1A/N-03-696 and packing plate PN 1B/N-03-696 (Ref Figure 3).

- F. Remove the existing rivets at the positions marked A in Figure 1 and rivet the reinforcing plate PN 1A/N–03–696 to the aircraft skin at the positions marked A. Wet assemble the rivets PN MS20470AD4–4 with pigmented jointing compound.

- K. Fit the support bracket in position shown in Figure 1 and secure to 1 stringers using pop rivets PN NAS1738E4–1. Ensure that the holes in the bracket align with those in the packing plate and reinforcing plate. Use Brisal bonding paste, or equivalent, in the area of the antenna mounting holes and wet assemble the securing rivets with pigmented jointing compound.
