SB-GA8-2008-49 Issue 1

Service Bulletin

MANADATORY WITH TCM (BENDIX) RETARD BREAKER MAGNETO INSTALLATION

TCM Starting Vibrators

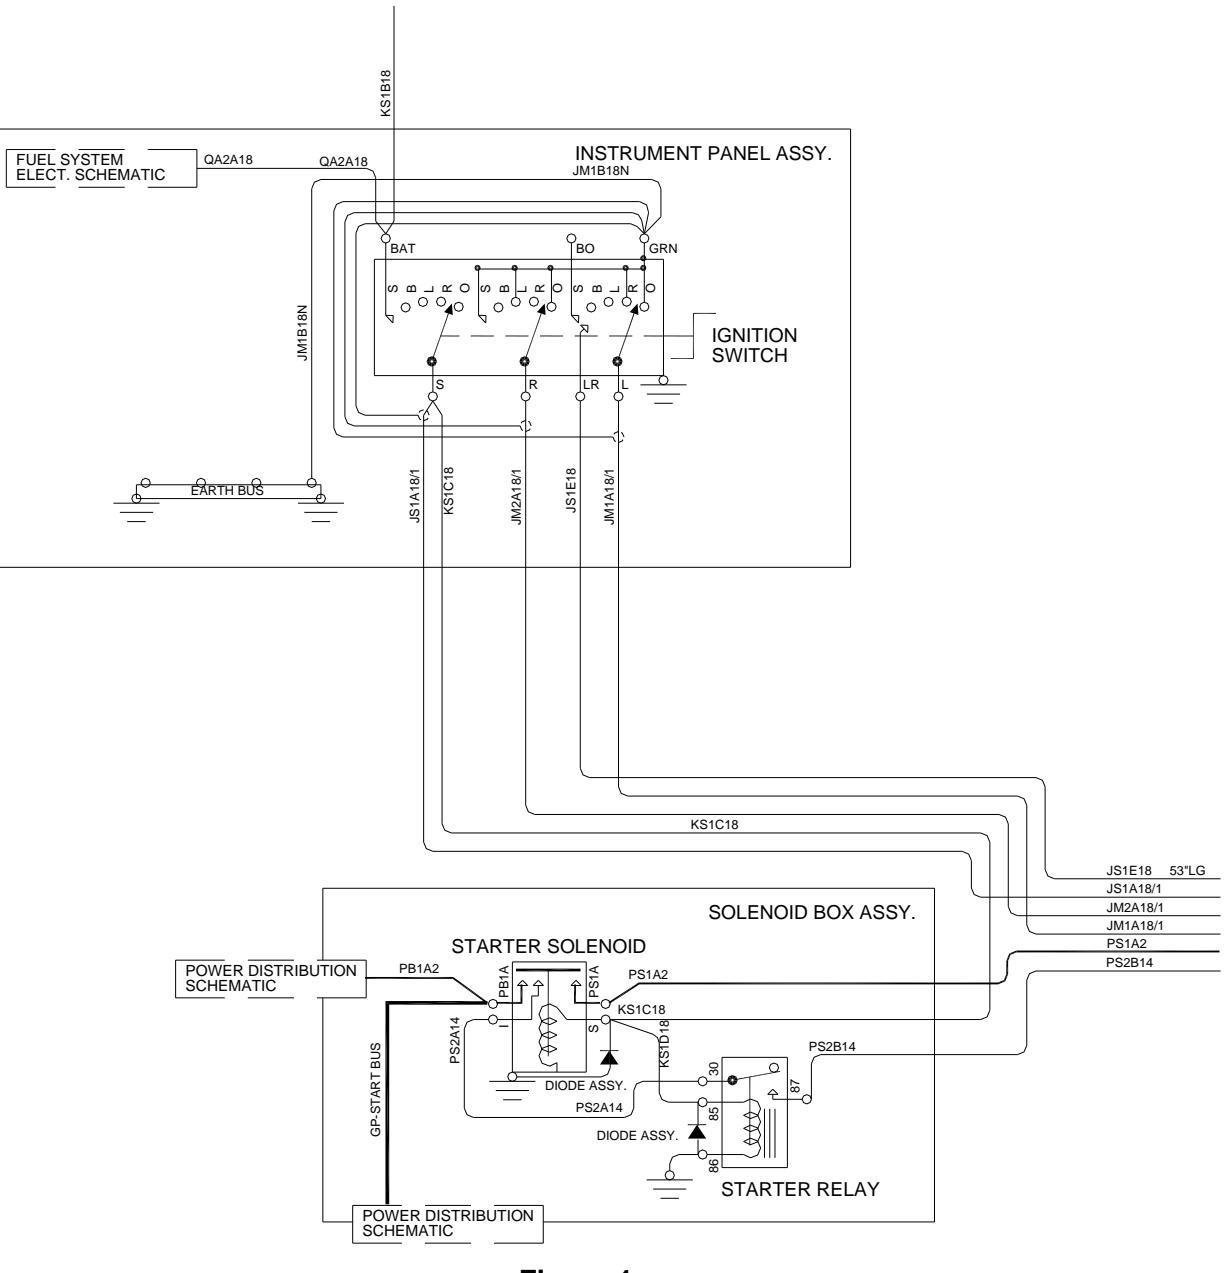
Option 2 is for the installation of TCM Starting vibrator without an internal relay to facilitate the use of a TCM retard breaker magneto. This option requires minor changes to the magneto wiring including the installation of an additional wire.

- 2.3 Remove the spade type connectors from wires JS1A18/1 and JS1C18/1 at the Slick Start end. Tie both ends of wire JS1B18/1 into the wiring loom.
- 2.4 Do not reconnect JS1B18/1 to the switch terminal on the Left magneto. Tie the earth wire JS1F22N into the wiring loom. Install wire JS1E18 as shown in Figure 1 and Figure 2.
