SB-GA8-2005-23

Issue 8

Service Bulletin

Forward Cargo Door Slide

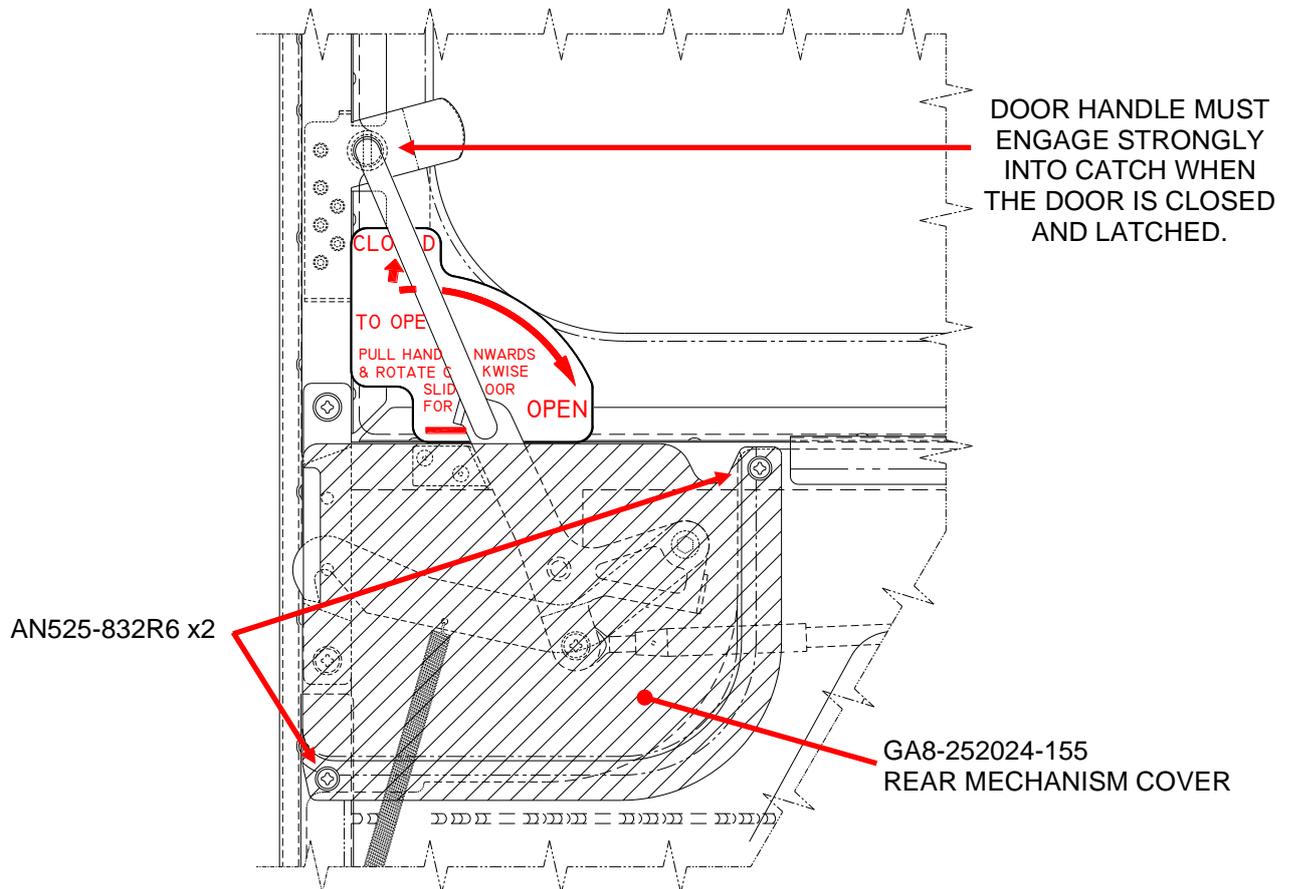
Figure 7: Rear Mechanism Cover (latch in closed position).

4. Check door adjustment as detailed in Section 52-20-10 of the applicable aircraft service manual.
5. Check that the door handle engages strongly with the catch when in the closed position (Figure 7). Weak engagement may be caused by wear to the handle bush or by damage (bending) of the handle and must be corrected by replacing the pivot bush (with Item 11 from Table 5) or the handle (Item 10 from Table 5) as appropriate.

6. After finishing inspection and required actions, reinstall the Rear Mechanism Cover as shown in Figure 7.
