SL-GA8-2007-07

Tow limit markings.

Service Letter

Applicability:			
All GA8 Aircraft.			
Background:			
This Service Letter has been issued to provide owners and operators who use motorised towing equipment with guidelines for applying turn limit markings on the lower cowl to prevent over travel and damage to the steering stops and/or the rudder control system.			
Parts:			
The travel limit markings may be applied to the lower cowl, in accordance with these instructions, using adhesive vinyl, paint or any similar method. Suitable markings can usually be sourced locally, if further assistance is required please contact the Gippsland Aeronautics Spares Department.			
Parts Availability:			
Parts can be obtained directly from Gippsland Aeronautics.

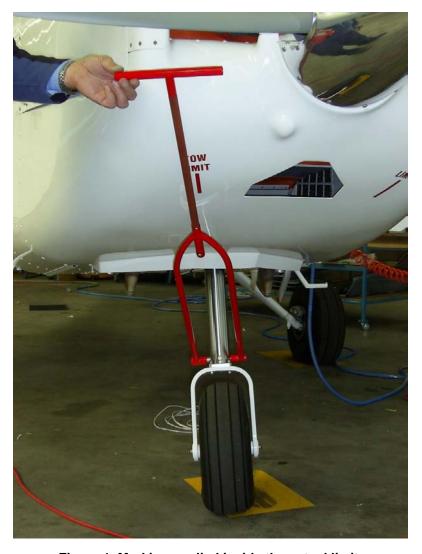
Figure 1. Marking applied inside the actual limit.

Determine the nose leg travel limit by using the hand tow bar as supplied with all Airvans by turning the nose leg until the rudder contacts the stops, then lifting the bar to the lower cowl and marking at the inside of the tow bar to give some tolerance as in Figure 1.

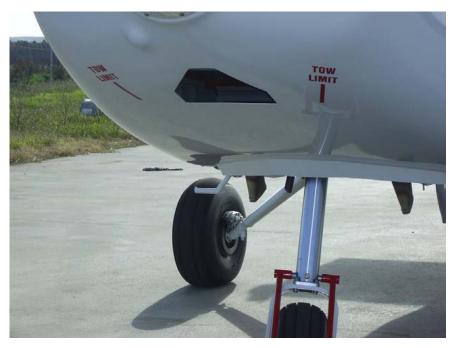
Figure 2. An example of "Tow Limit" markings.

Due to varying operational requirements, markings can be applied to show towing limits with sizing to suit individual aircraft/operation.

Additionally a placard stating "tow limit" or similar may be applied at the operator's discretion.
